Town of Chester Road Erosion Inventory 2015

Completed by Southern Windsor County Regional Planning Commission and the Town of Chester

Fieldwork completed October 2015

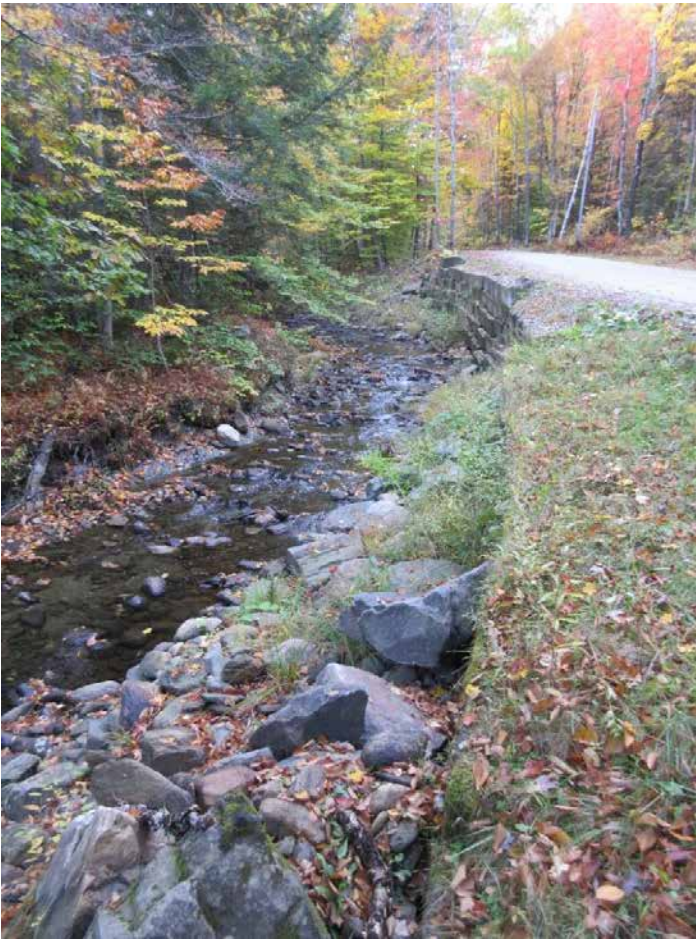
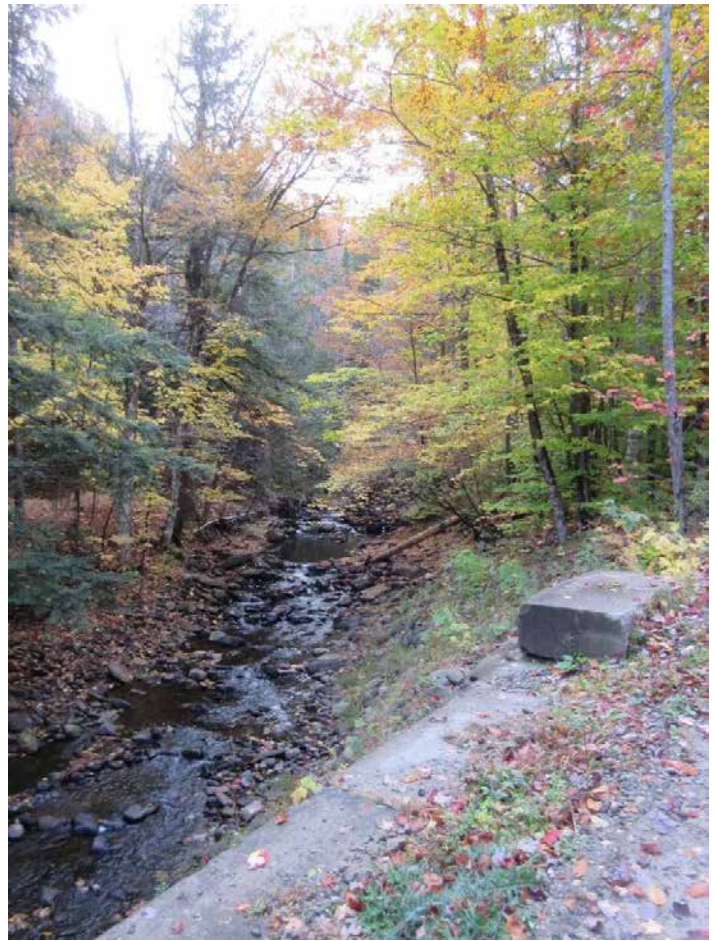
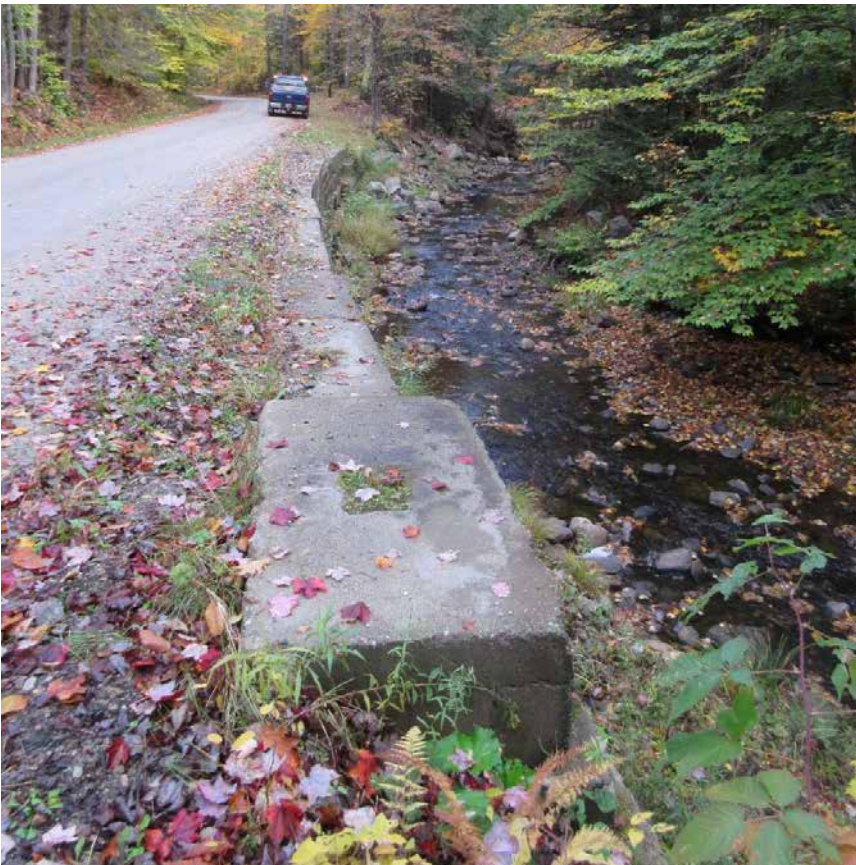
- Stream right next to the road on a river bend.
- Road has issues with flash flooding (most recently 2011 and 2014) and beaver dams (every few years).
- Currently has 6ft concrete blocks to keep the bank vertical (160ft long, 14ft high), but that is not good hydrologically and not a permanent fix.
- Road washes out regularly and the existing concrete blocks will eventually fail.
- Site also needs guard rails, but there currently is not sufficient space.

While there are several other similar sites on Popple Dungeon Road, this one is taller and closer to the road than the others. This site also already has a temporary fix that will not last through another big rain event.

Top left: Looking west (upstream) across the site
Top right: Looking west (upstream) from the site
Bottom Left: Looking east (downstream) across the site

- Road and river right next to each other with a vertical wall that is not good hydrologically.
- Cannot move the road much laterally – not much space in existing ROW, would need to raise the road and move utilities

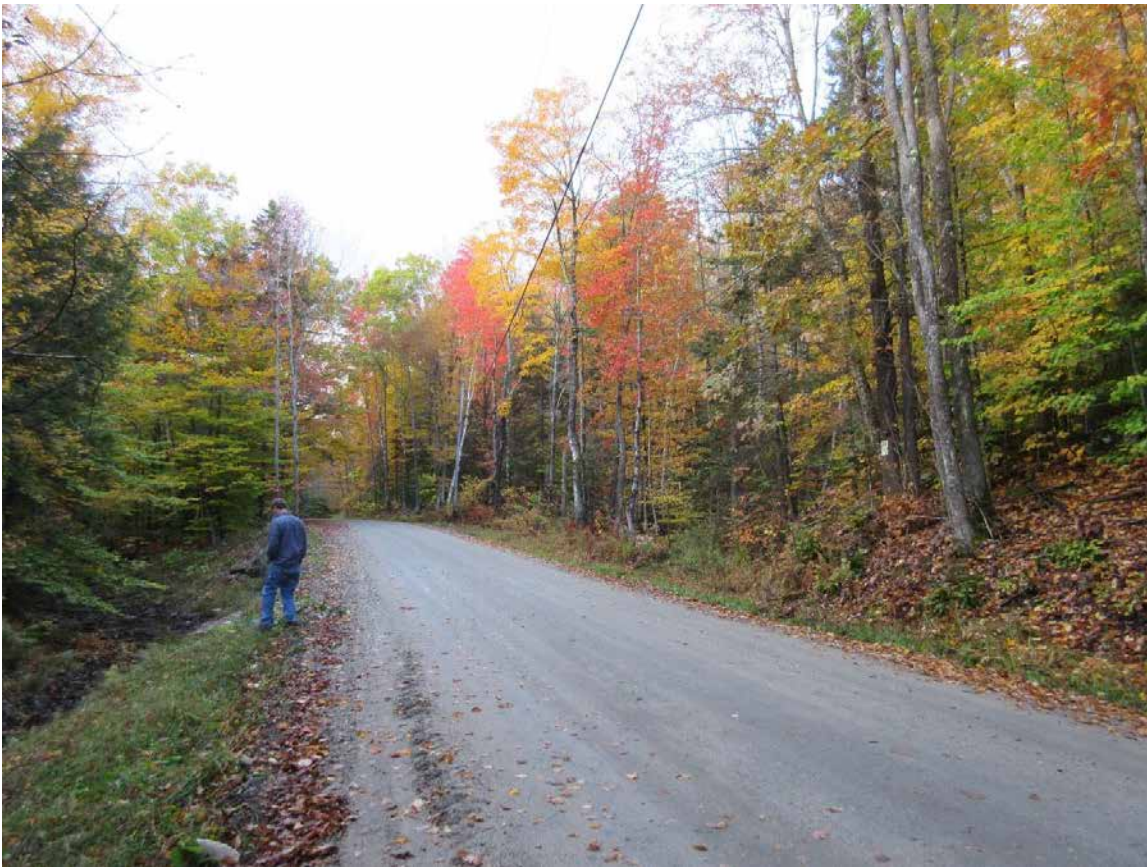
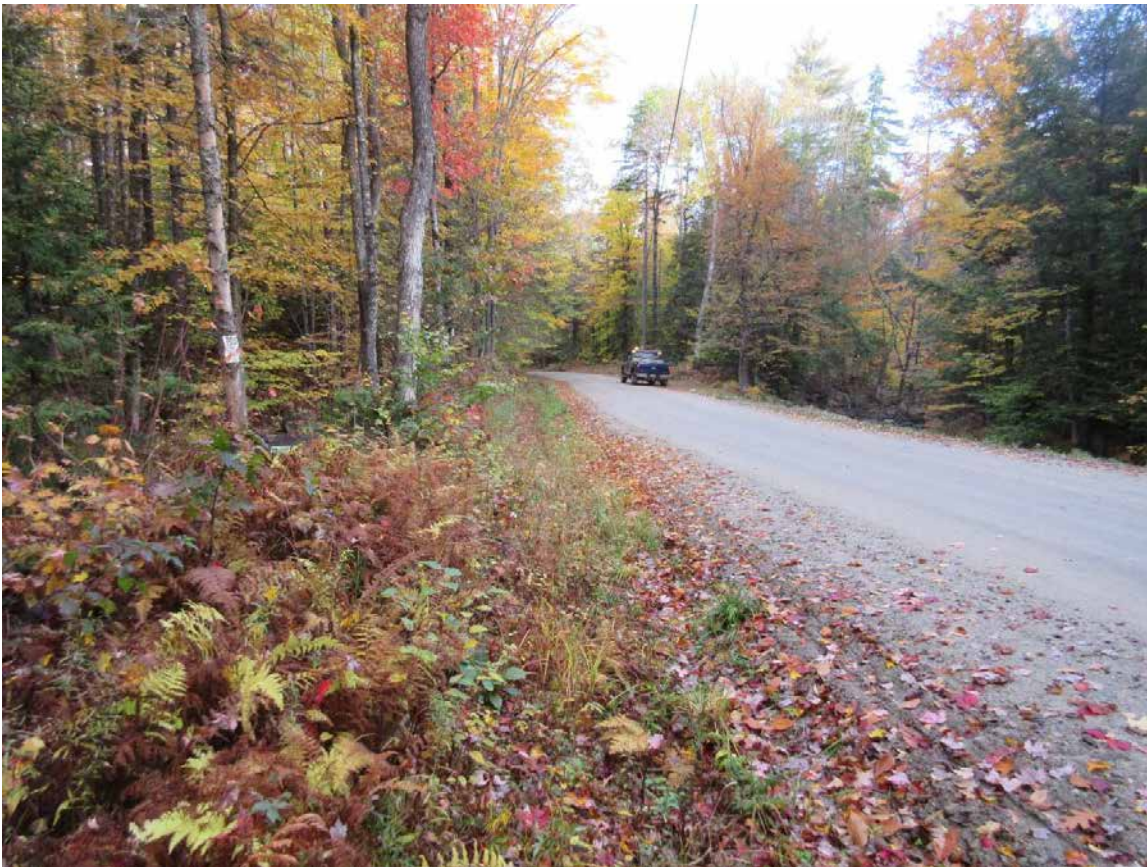
Top: Looking west up road

Bottom: Looking east down road.

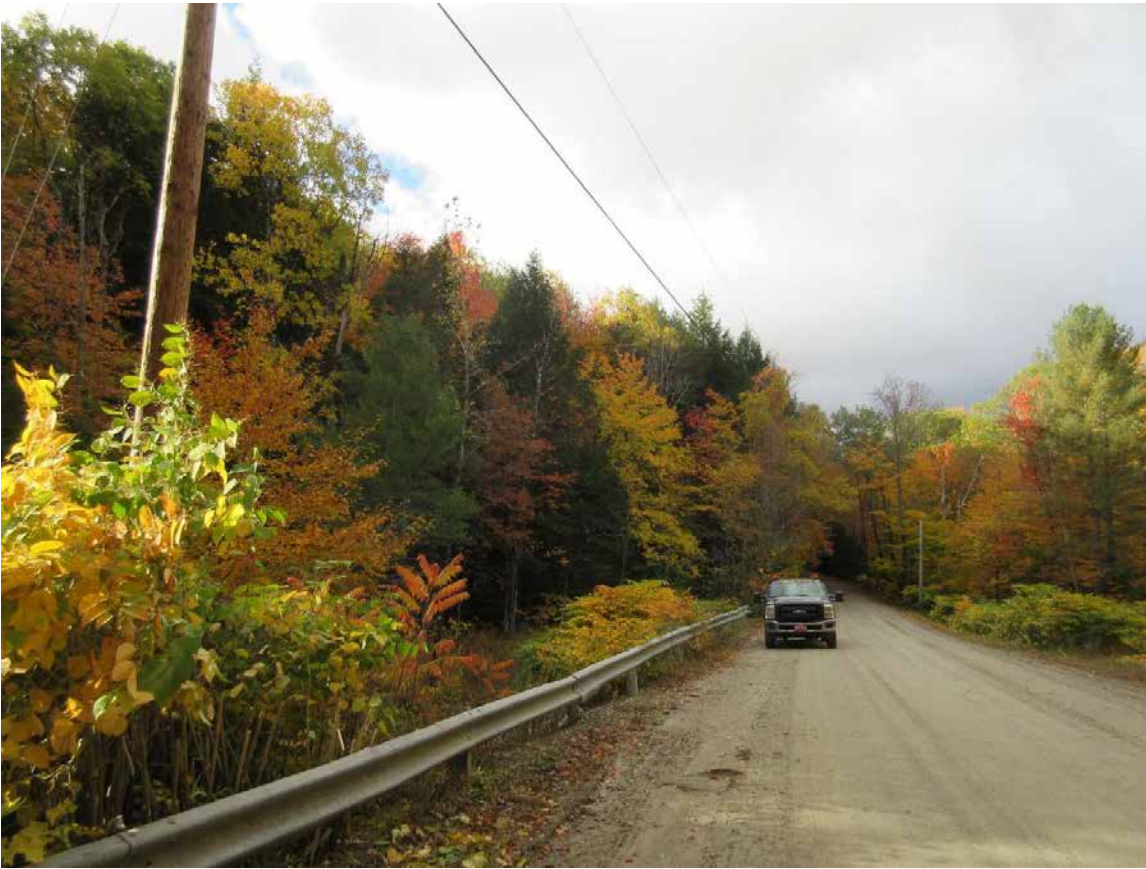
- During major rain events and the resulting fluvial erosion, an approximately 100ft section of road repeatedly washes away as it becomes the flood chute (most recently in 1996, 2011 and 2014).
- The river approaches the current large elliptical multi-plated culvert at an angle.
- Each time the river creates the flood chute fill is needed for a section of roadway 120ft long, 20ft high and 60ft in width.
- It is currently a squashed 11ft corrugated culvert. It has a rusted out base, so water is now undermining underneath and to the sides of the culvert. It is also perched – which causes a barrier for aquatic organism passage.

Top: Looking west across the site. Treeline marks edge of flood chute.

A 80-100ft long bridge or very large box culvert might alleviate the issue. Would probably cost \$500,000 - \$750,000.

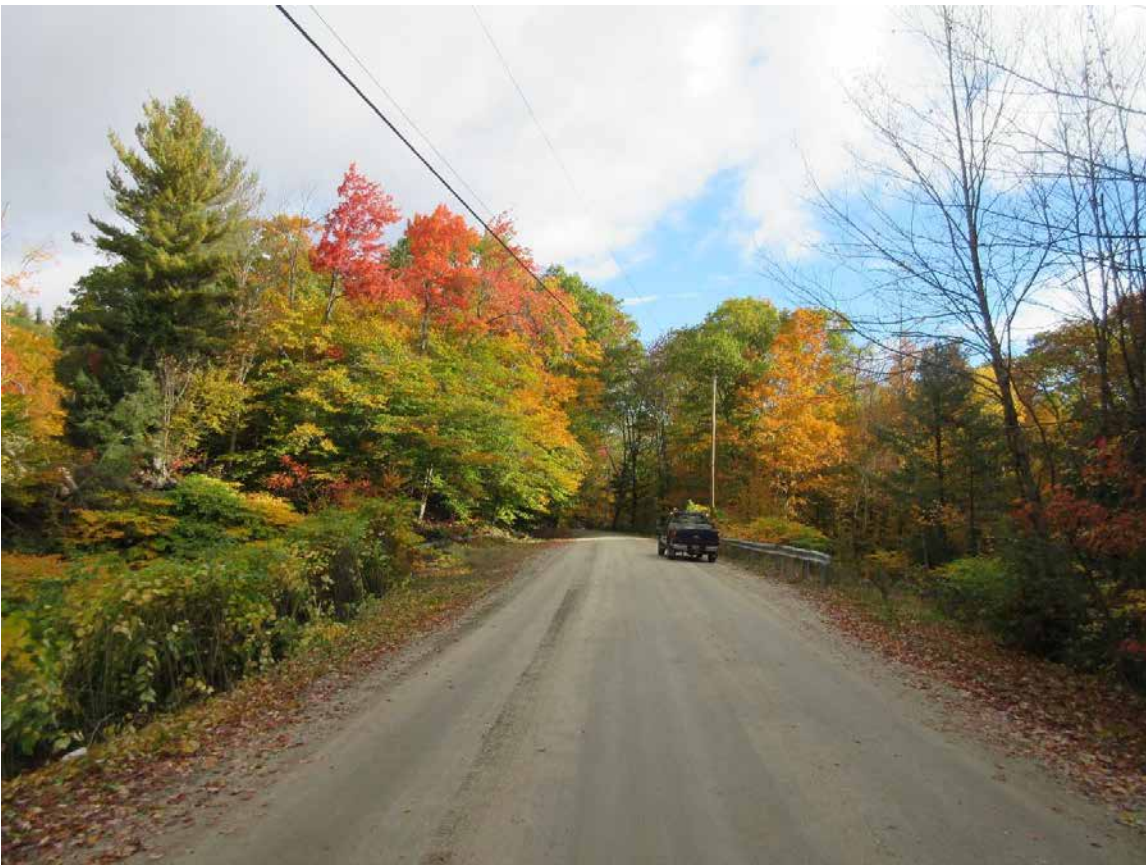
Bottom: Looking east across the site. Flood chute extends from where to the photographer is standing to the treeline/ just beyond the truck.

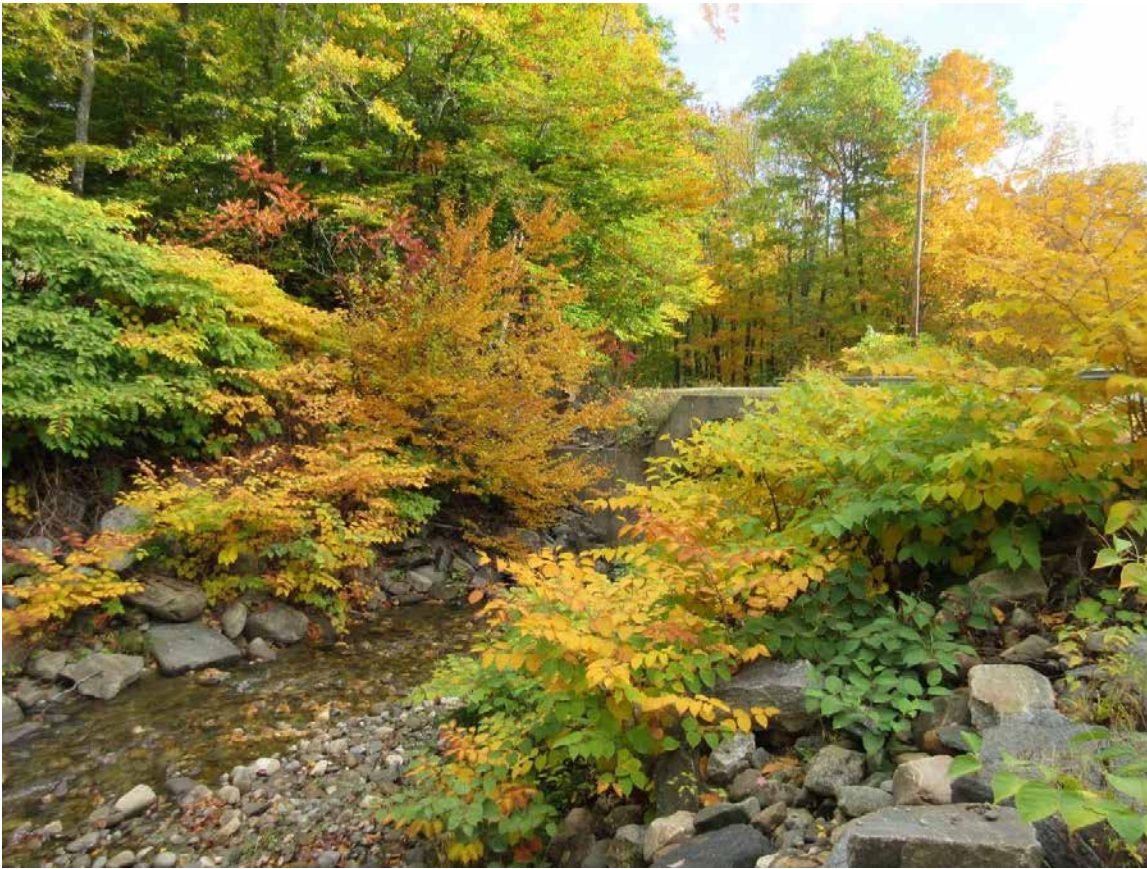
Top: Looking at upstream end of culvert.

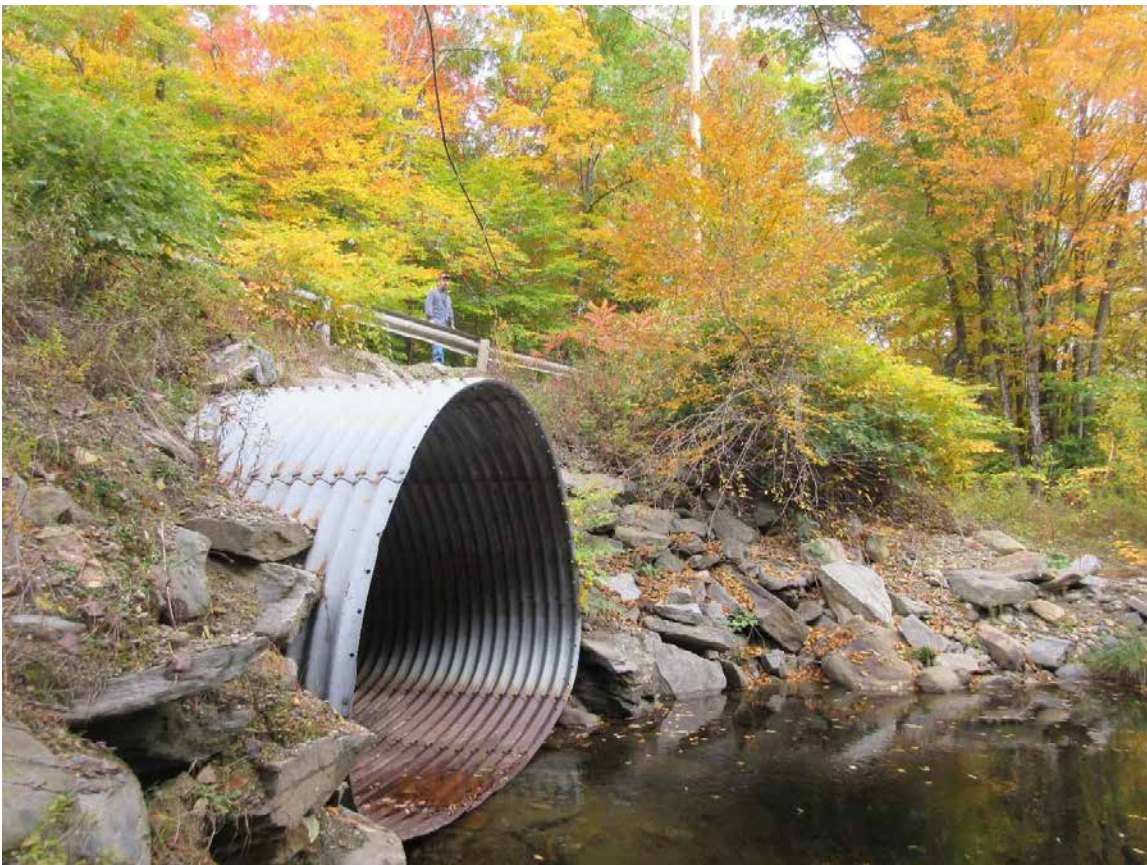
Bottom: Looking at downstream end of culvert

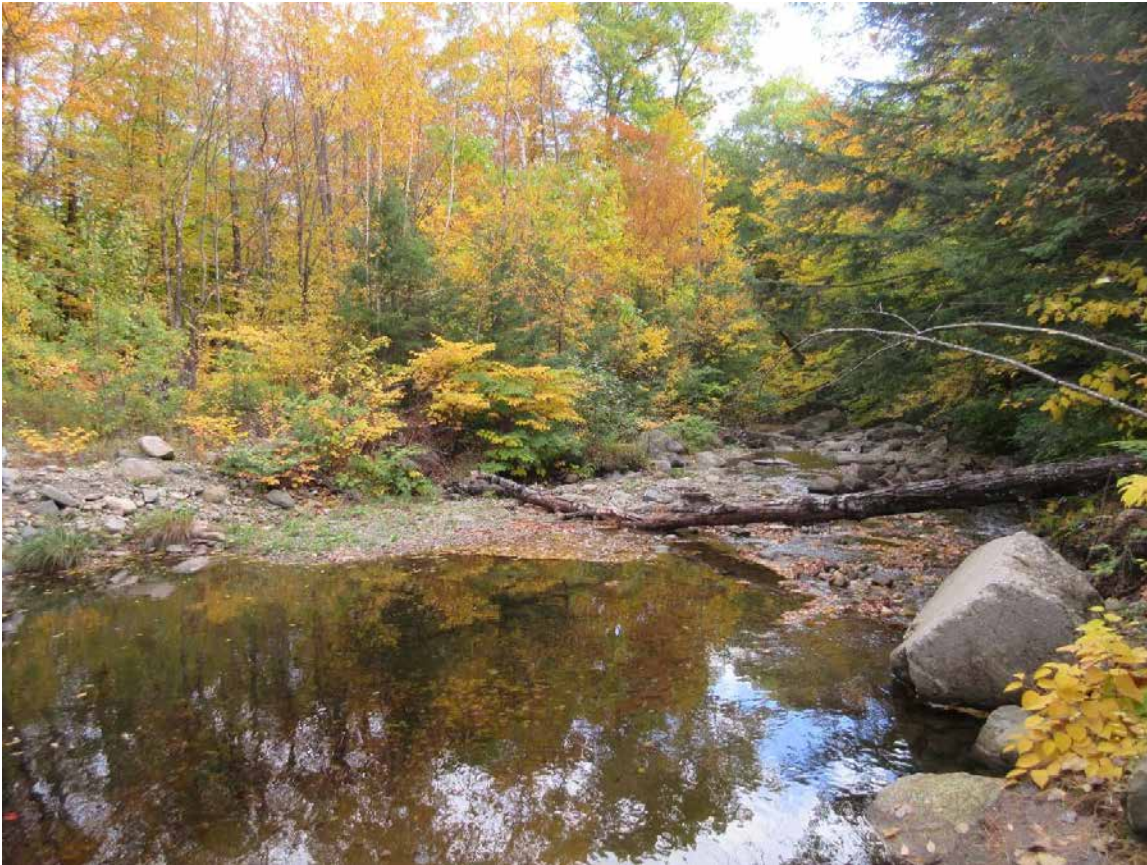
Top: Looking
downstream from site

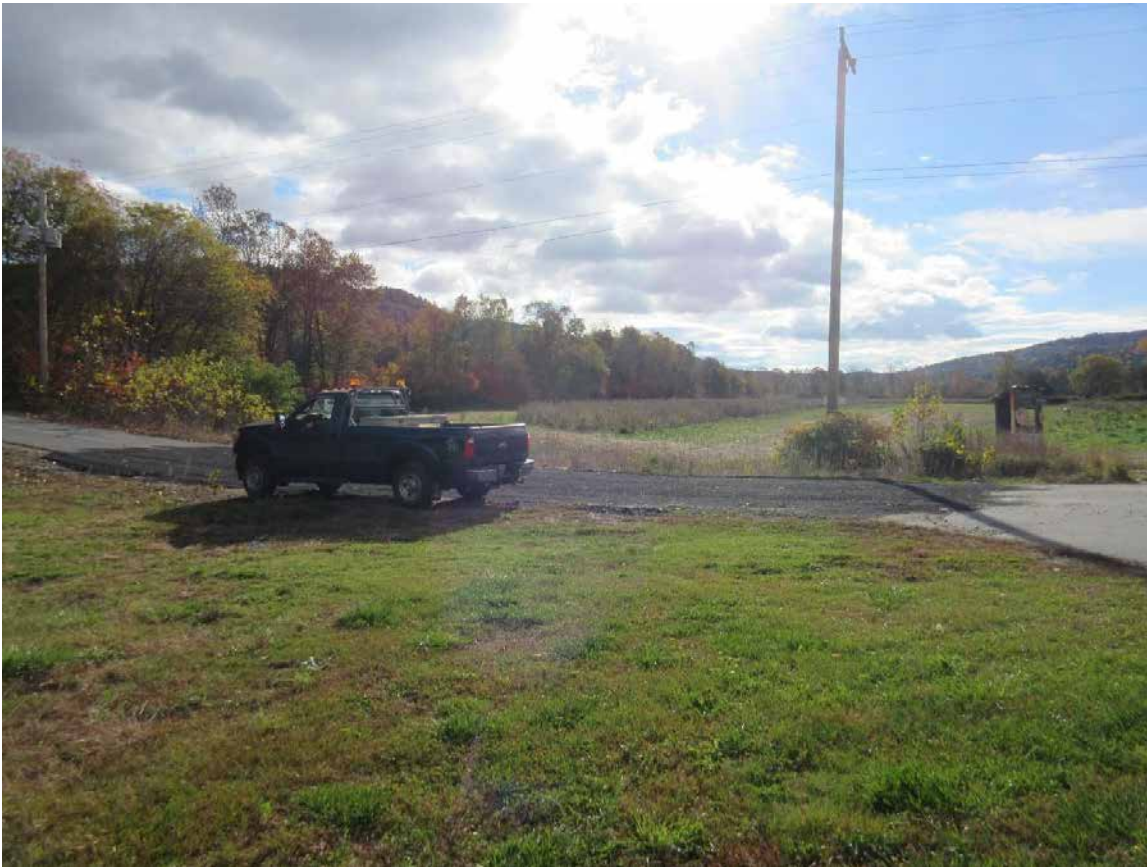
- Williams River creates a flood chute in extreme rain events that cuts across the Ball Field and Sewer Plant Road. This happened in both 2011 and 2014.
- The river would overwhelm anything you put in – culverts, bridges, etc – so instead the highway department has used a temporary fix. The temporary fix is an unpaved section within the paved road, just filled with crushed gravel after each event to restore the roadway.
- This road is important as it serves the town sewer plant.

Top: Flood chute site looking east toward field.

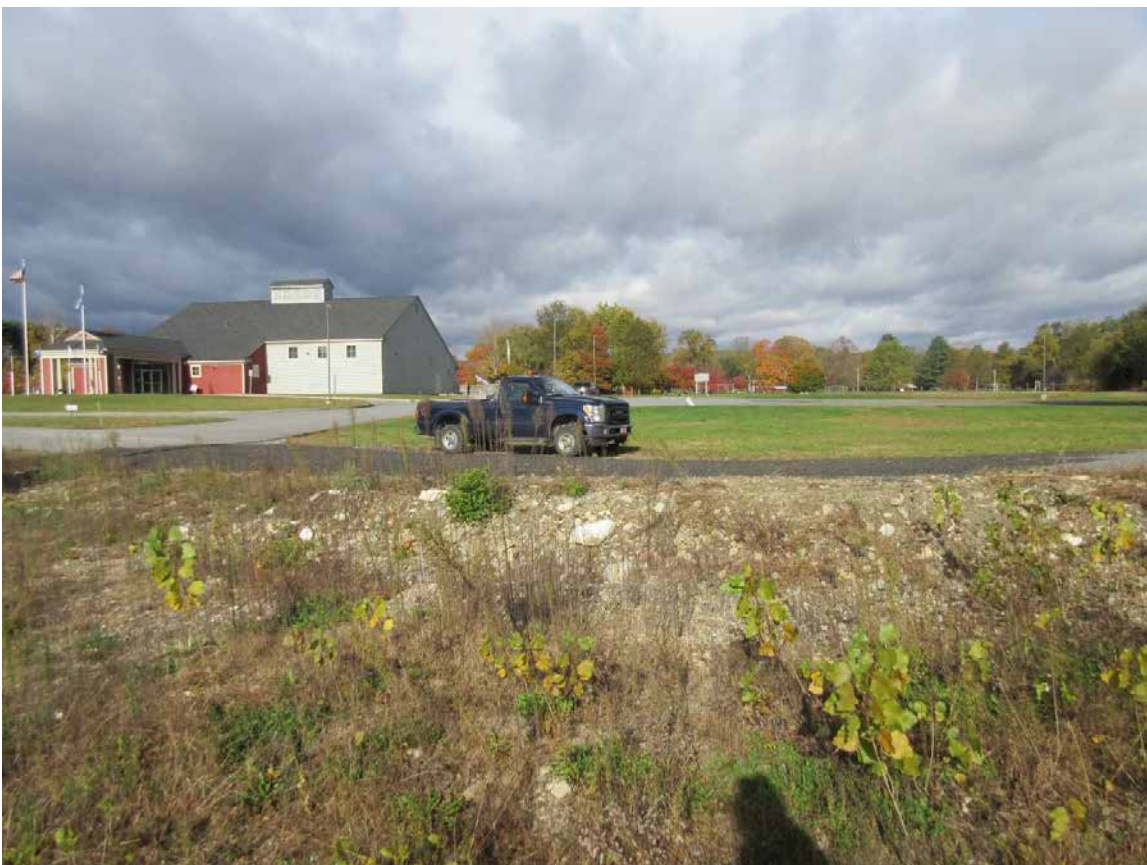
Bottom: Flood chute site looking west toward ball field and parking area

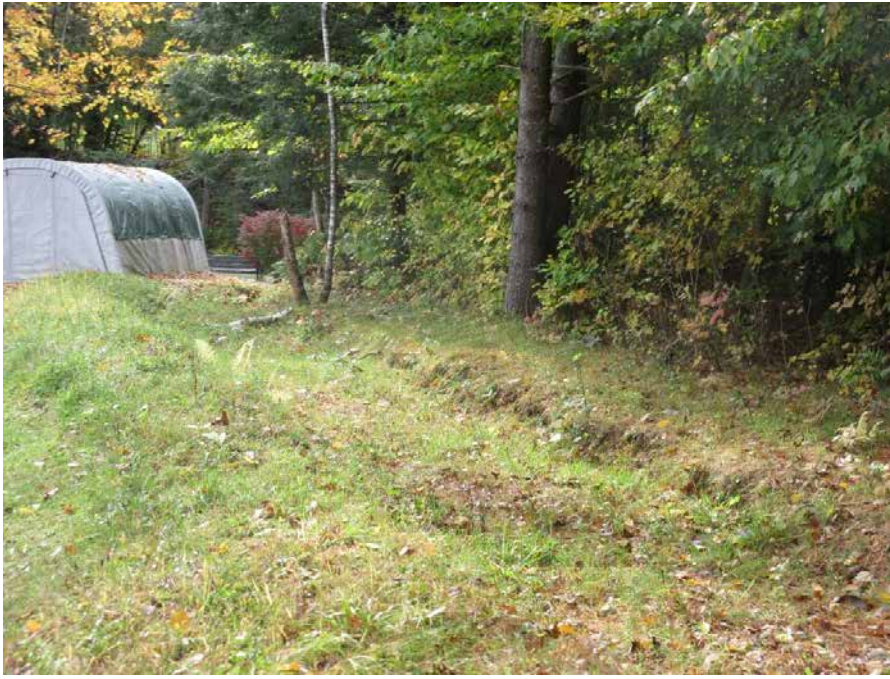
- Water runs down a steep hill onto the residential development below (Marshall Road and Kevadus Circle).
- From about halfway down the hill the unpaved roadway has been graded with a cross-slope so that:
 - 90% of the water drains into the ditch on the south side which then runs into a chute which flows into a stream. This chute has a good amount of distance and grass between the roadway and the stream to prevent water quality issues.
 - 10% of the water drains into the ditch on the north side which then runs through a short amount of very steep woodland into the residential development below. This development does not have any storm water capacity and the water table is very close to the surface there.

Top left: Chute that connects base of unpaved road to the nearby stream.

The relatively small 10% of water than ends on the residential development would not be an issue if there was adequate stormwater drainage. Therefore installing storm drains and improving drainage on Kevadus Circle and the paved section of Marshall Road is the proposed solution. Costs are unknown as further engineering is needed.

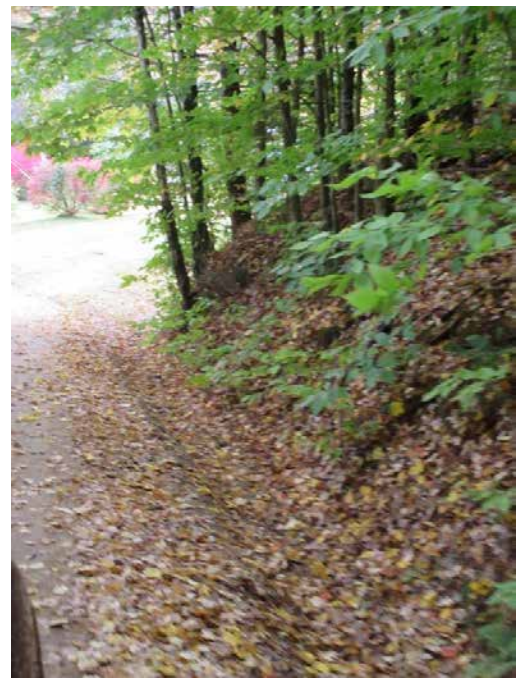
Top right: Ditch on south side of Marshall Road that carries approx. 90% of road runoff

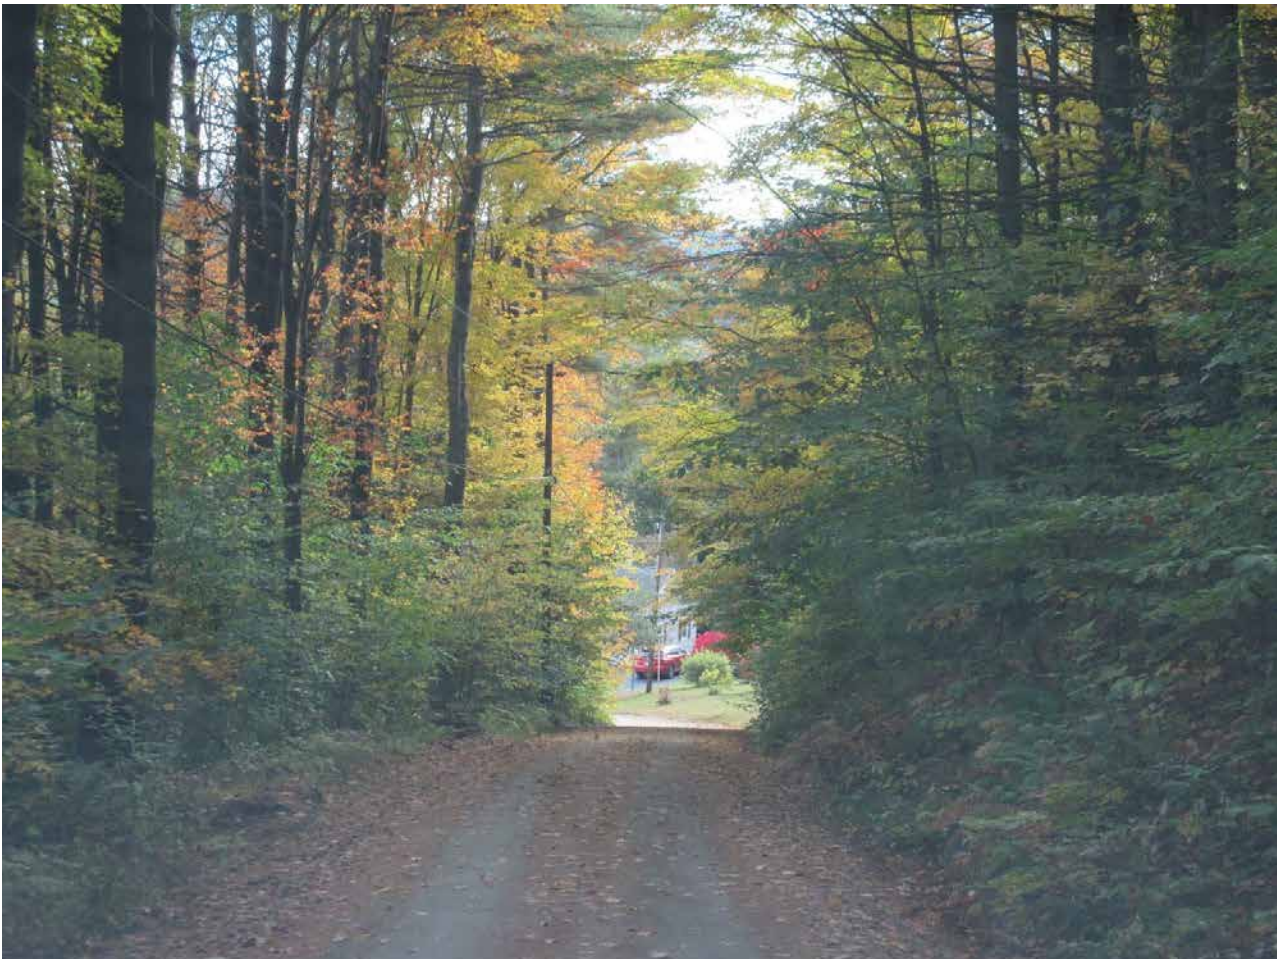
Bottom: Looking down unpaved Marshall Road toward paved Marshall Road (just before red truck)

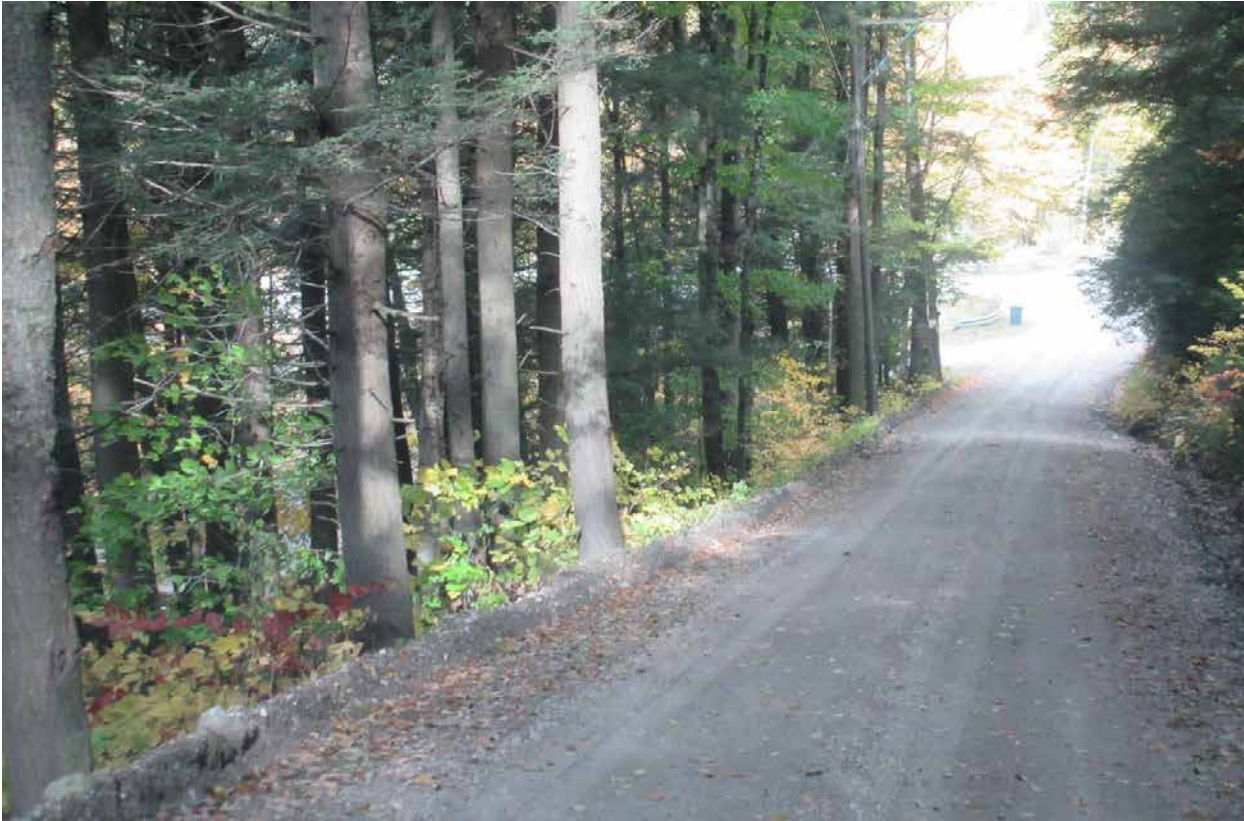
- Very steep roadway where ditches are easily overwhelmed.
- Small berm (half a foot) on the downslope side keeps the road together, but cannot last forever.
- Sheets of water go over the road and the side of the road straight into the stream causing a water quality issue

Top: Looking down Murdoch Road

Reinforce the downslope side of the road with riprap. Need to keep the trees in place, but the trees would cause issues for large rock.

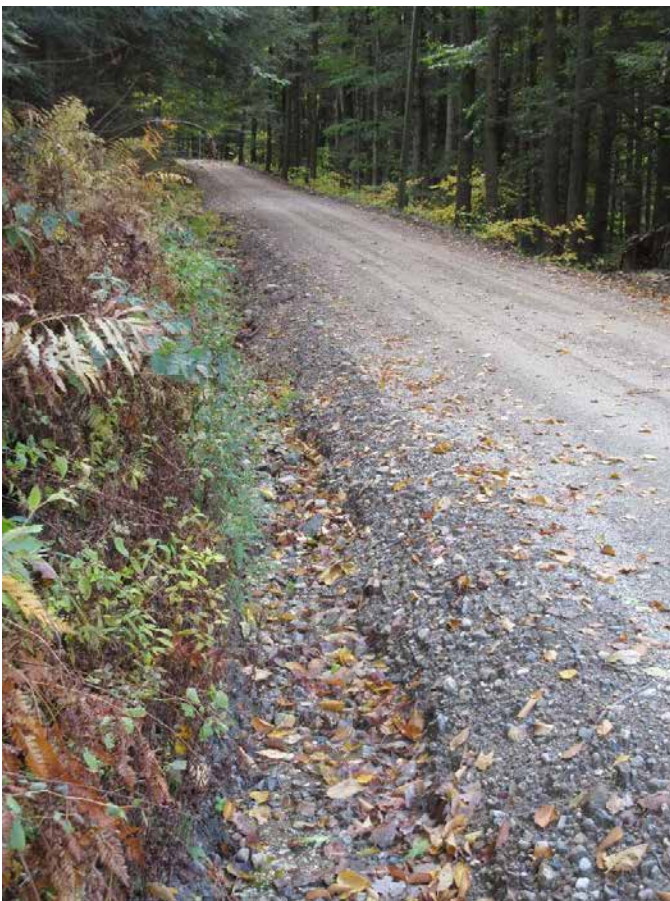
Bottom Left: Looking up along the upslope side of the road.

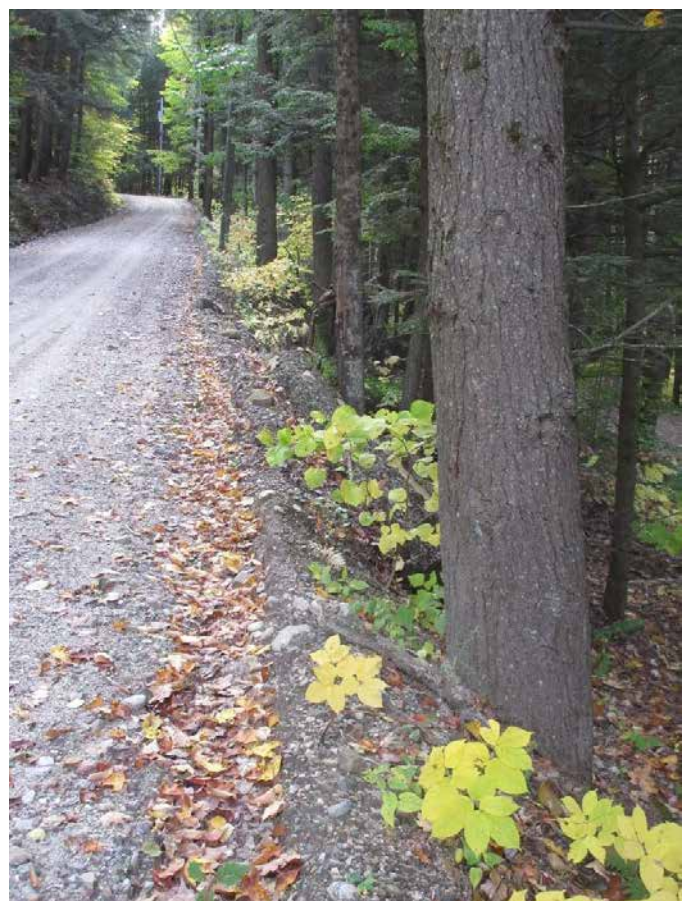
Bottom Right: Looking up the downslope side of the road which includes a small berm.

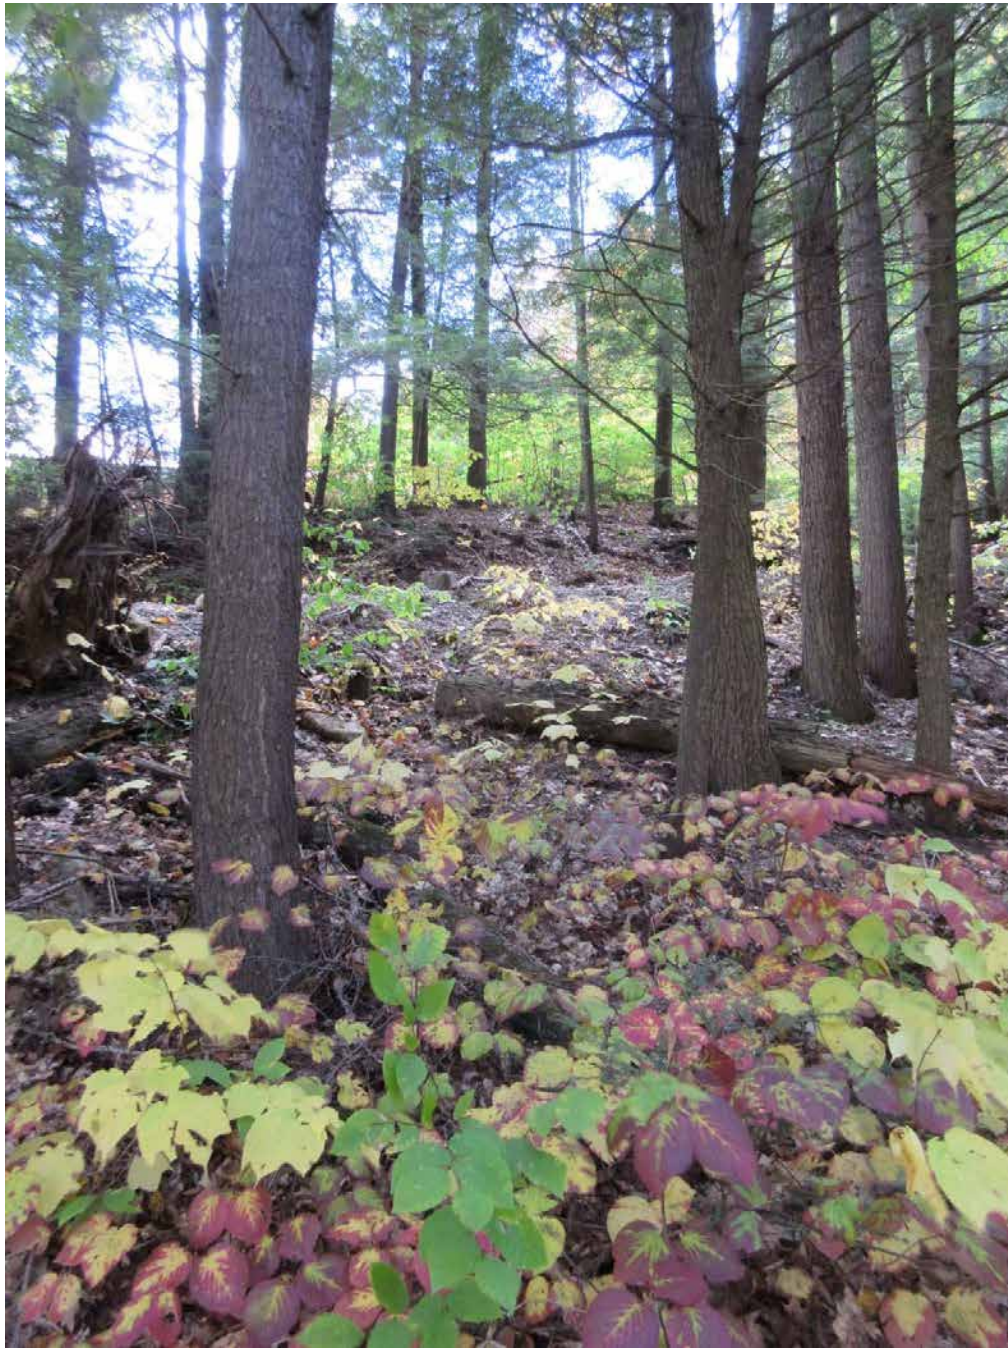
Steep cross-slope of roadway.
Roadway cuts through the hillside
around where the red arrow is

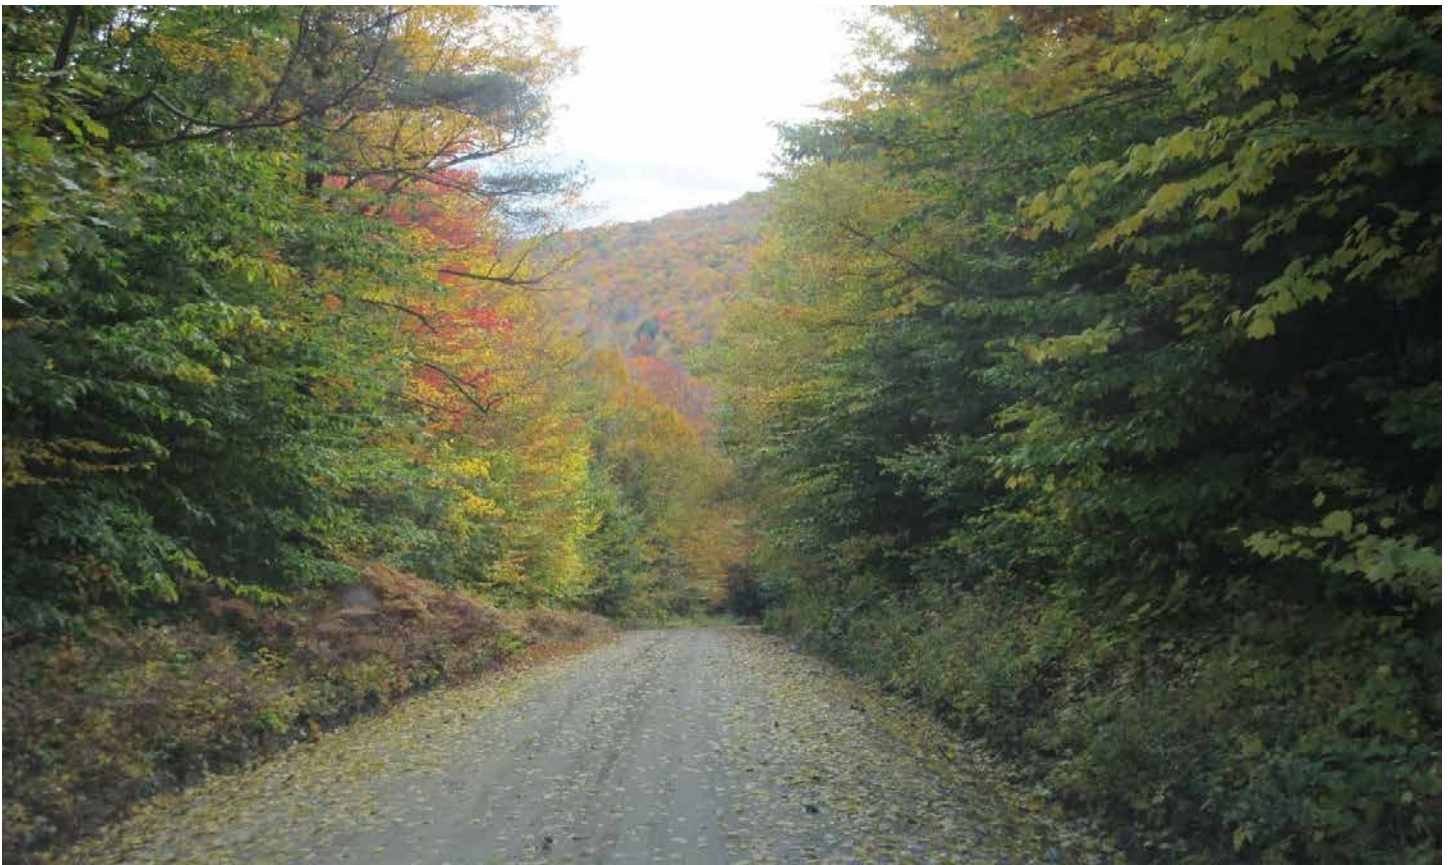
- Very steep roadway.
- Ditches need improvement.
- Area does not have a water quality issue as the water leeches into the woods before it reaches the closest stream.

Top: Looking down Miner Road.

Install stone lined ditches. Culverts should already be adequately sized

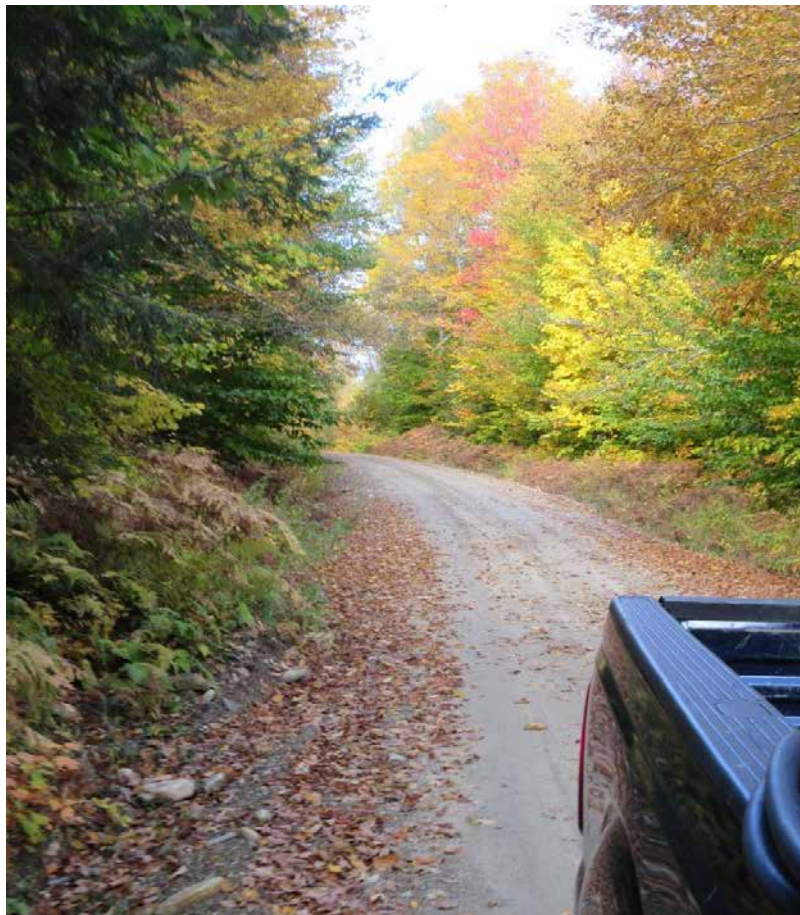
Bottom: Looking up Miner Road

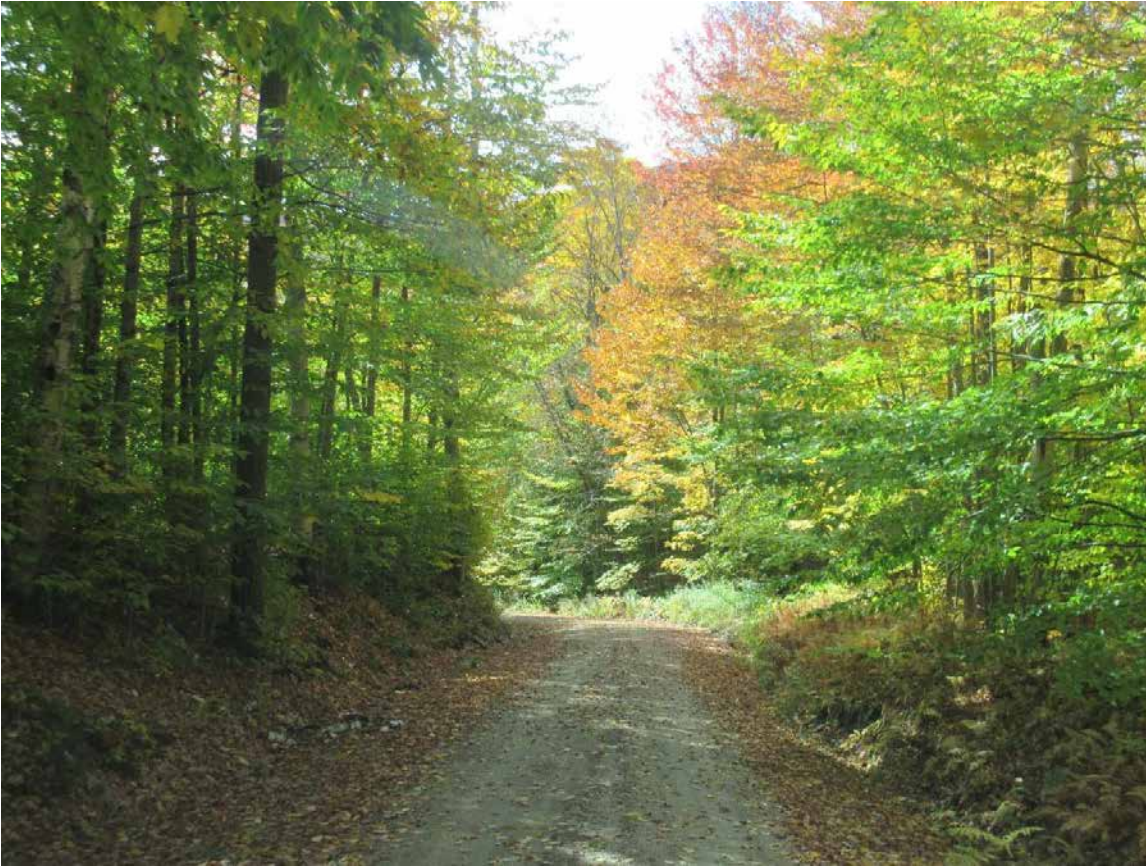
- Very steep roadway.
- Ditches need improvement.
- Area has water quality issue because the water flows straight from the road into the adjacent stream.

Top: Looking down
Pleines Road.

Stone lined ditches with turnouts. Existing culverts should be okay.

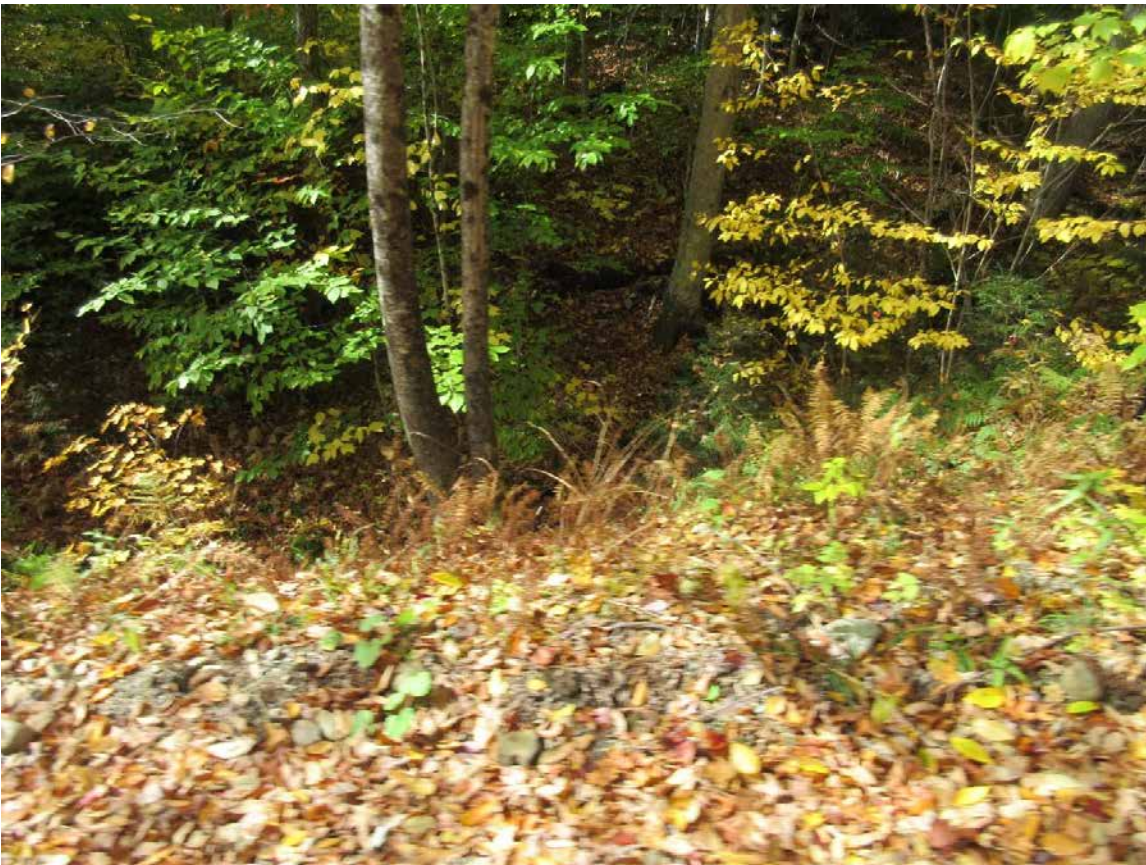
Bottom: Stream just
beyond edge of
roadway.
