Town of Chester Road Erosion Inventory 2015

Completed by Southern Windsor County Regional Planning Commission and the Town of Chester

Fieldwork completed October 2015

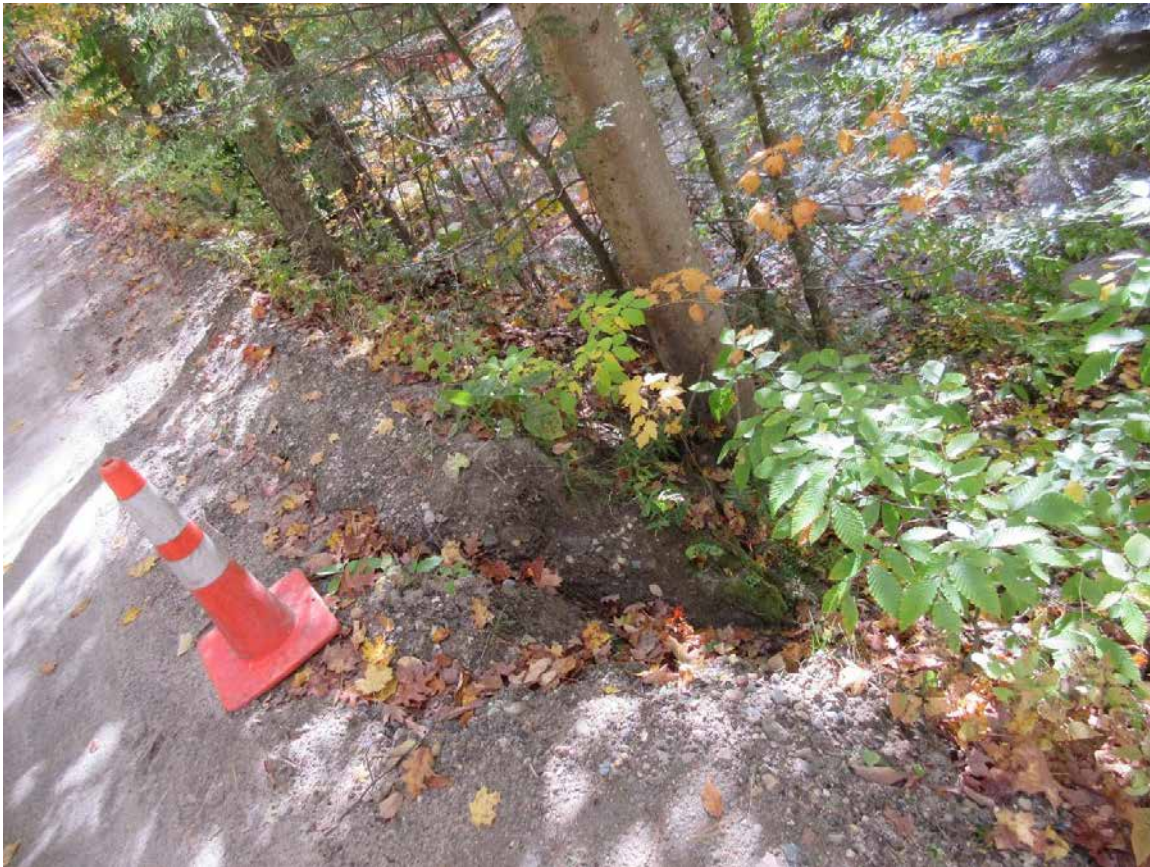
- Road edge starting to collapse and undermine right next to the stream. One very small section currently has issues, but problem will occur along far longer section of roadway before too long – only a few trees left holding the bank together.
- Steep (vertical) slope of approximately 15-20ft between road and river.
- Road cannot move very far away from the river as ledge is very close to the road edge, and there is another steep road paralleling the road just above it (Suursoo Road) which would have to be relocated if Smokeshire Road was relocated.

Top: Road edge starting to collapse into river.

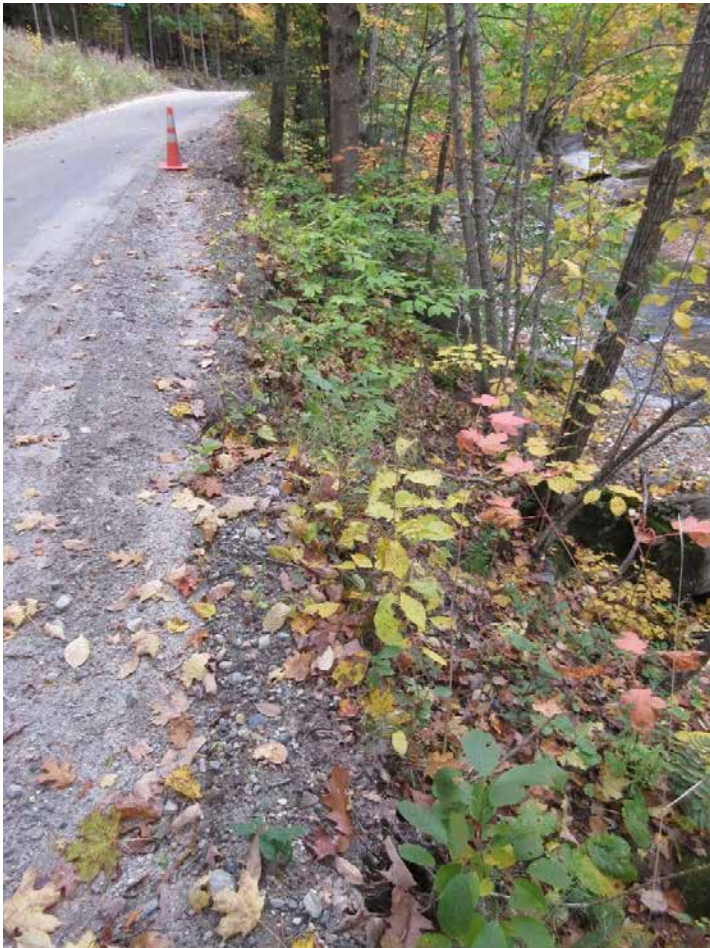
Bottom left: Looking downstream (east) from existing collapse site.

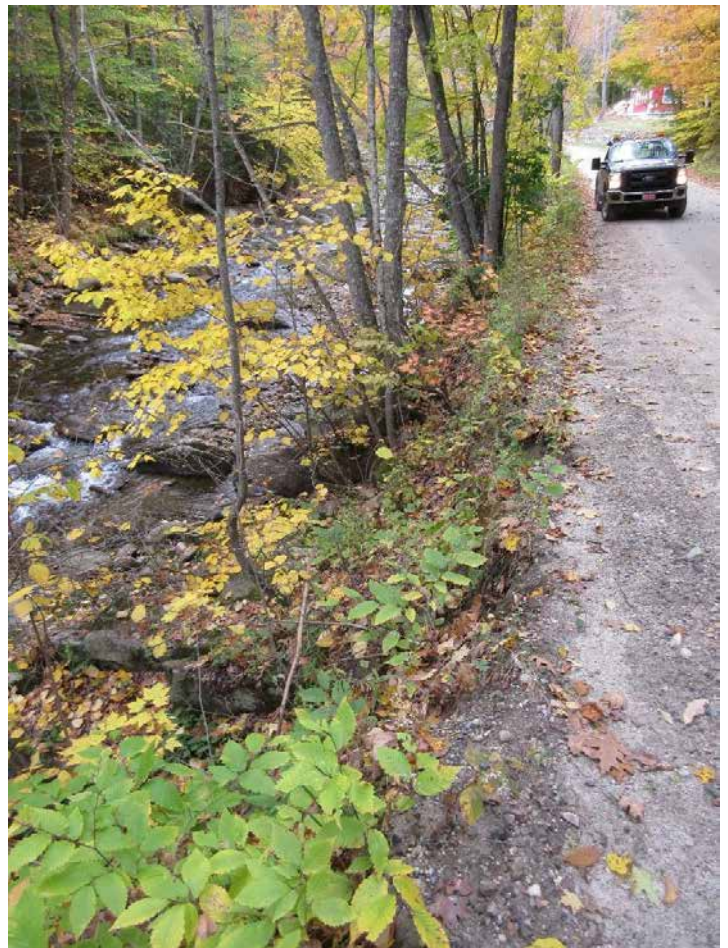
Bottom right: Looking upstream (west) from existing collapse site.

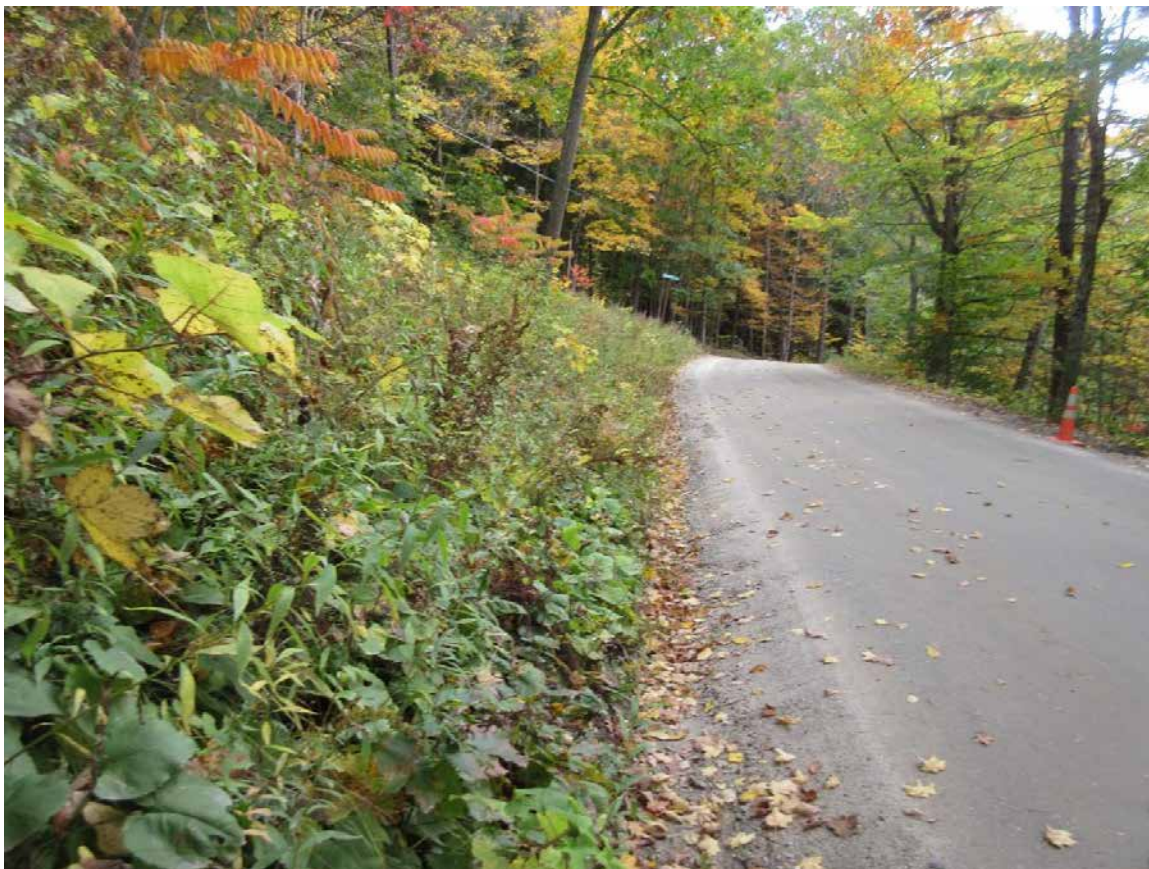
Top: North side of road,
looking east towards
Suursoo Road
intersection (at crest of
road)

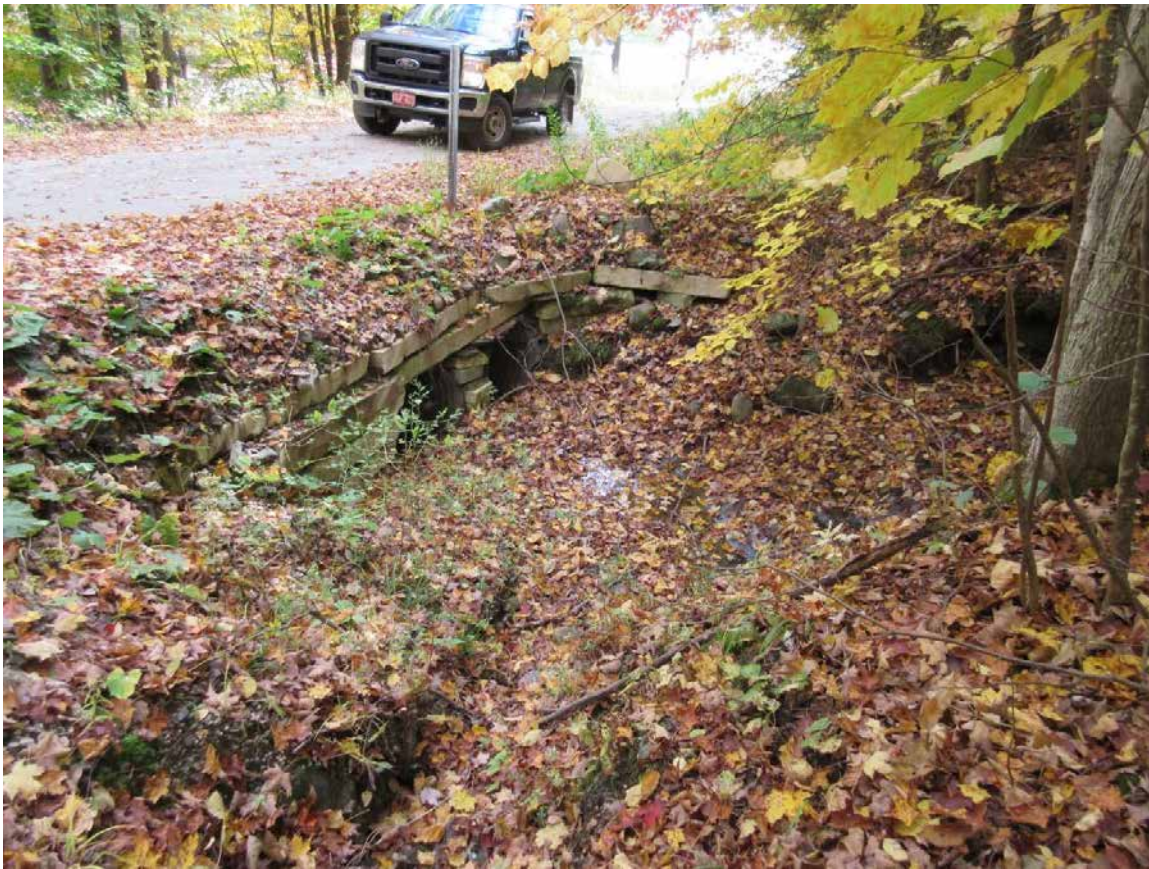
- Double culverts (both 24 inch diameter) do not adequately handle water – particularly during icy conditions.
- Complex situation including a steep bank with waterfalls and pools below – which end right next to VT-103.
- Culverts have marble headers – which are not found anywhere else in town – except within VT-103 ROW. Unknown reason

Top: Double culvert inlet with marble headers

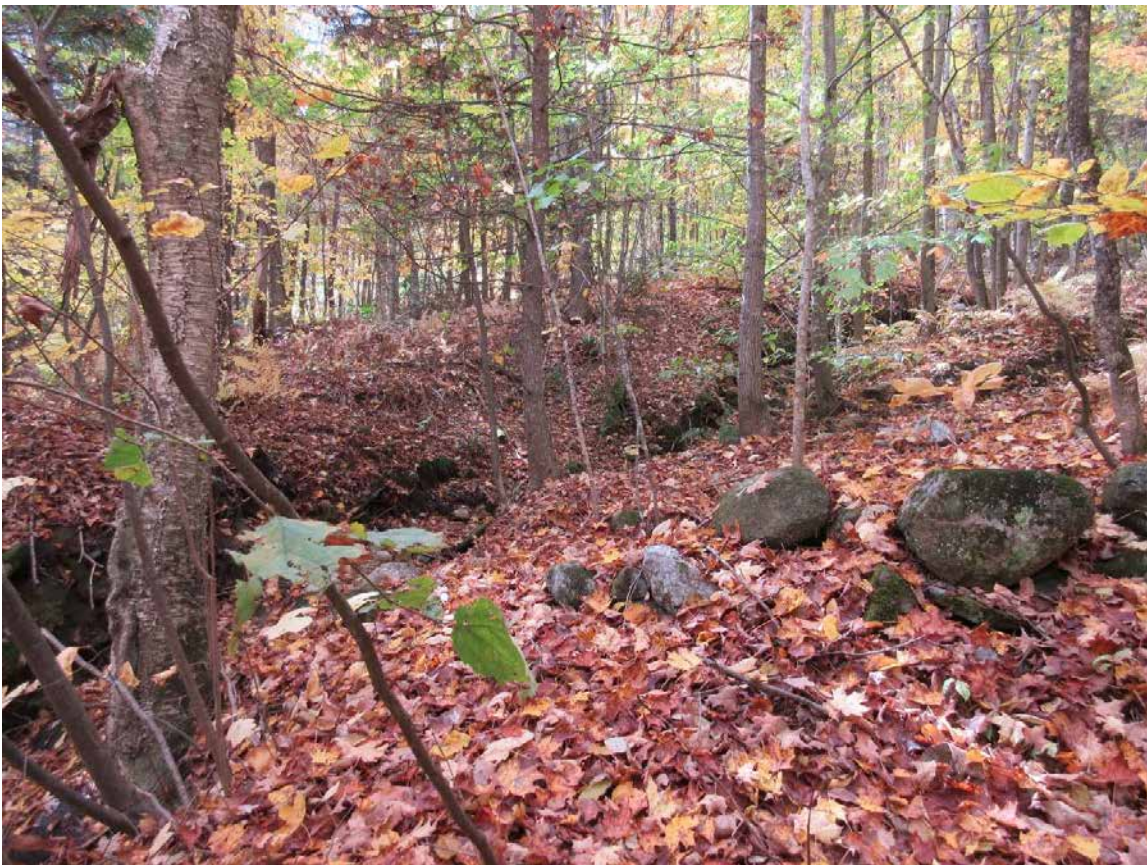
Bottom: Narrow gully with stream that feeds the double culvert.

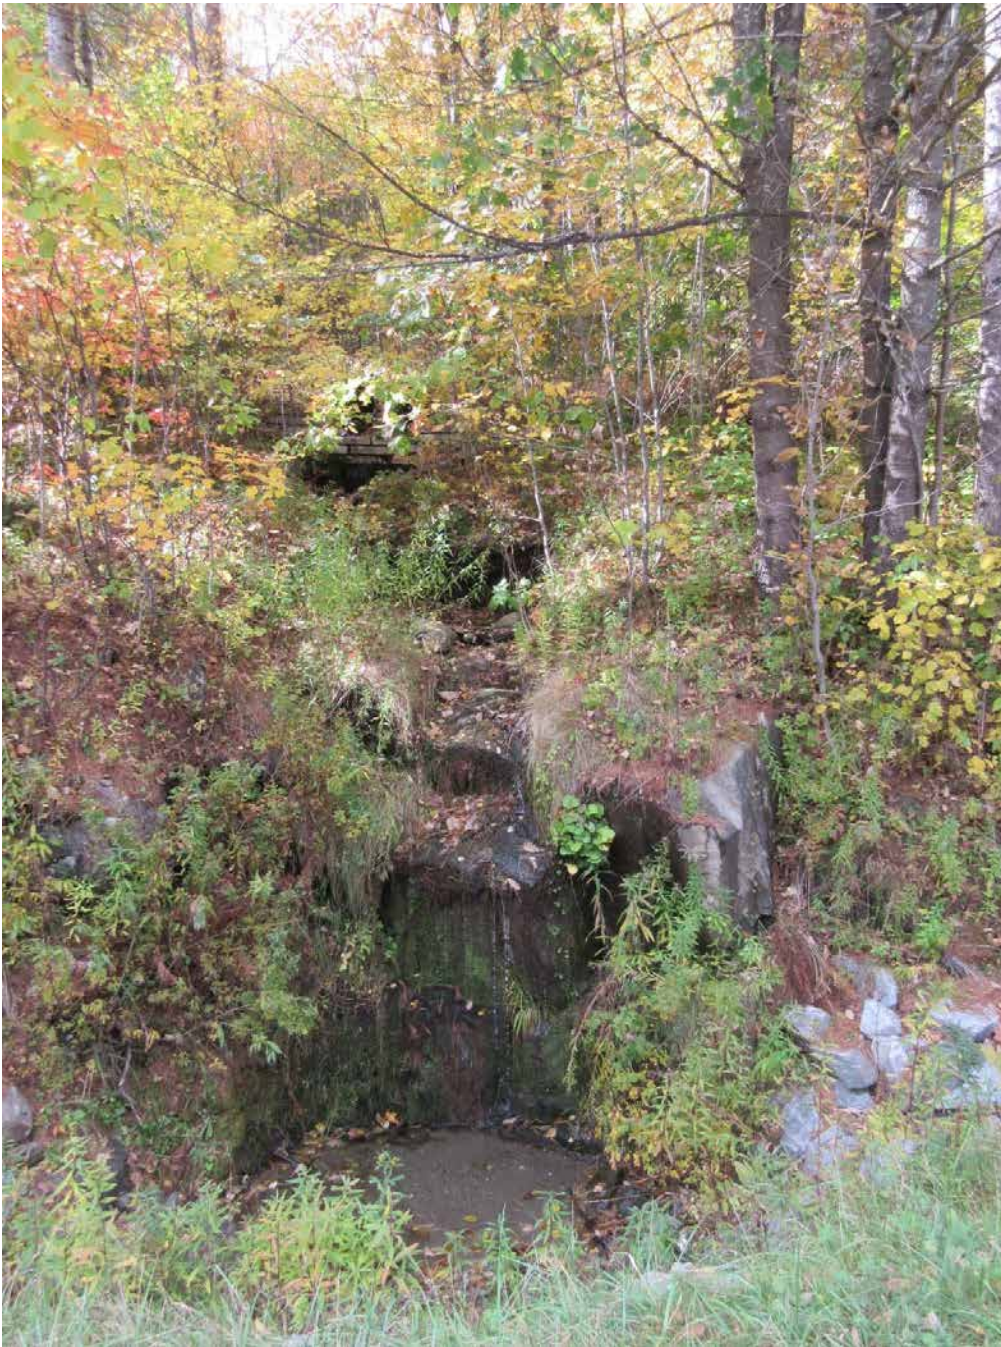
Top: Looking at outlet of double culvert from edge of VT-103 Right-Of-Way. Waterfalls and pools below culvert. Base pool directly adjacent to pavement edge.

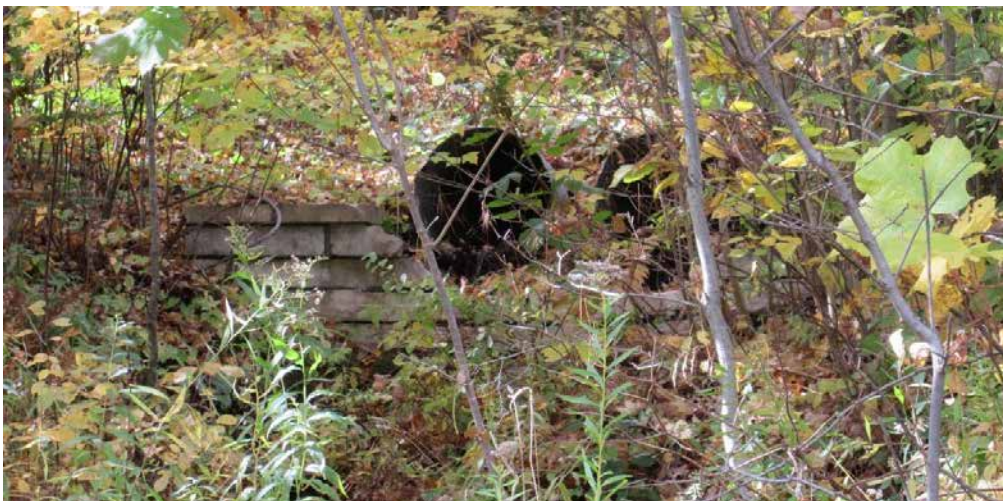
Bottom: Detail of double culvert outlet as viewed from VT-103.

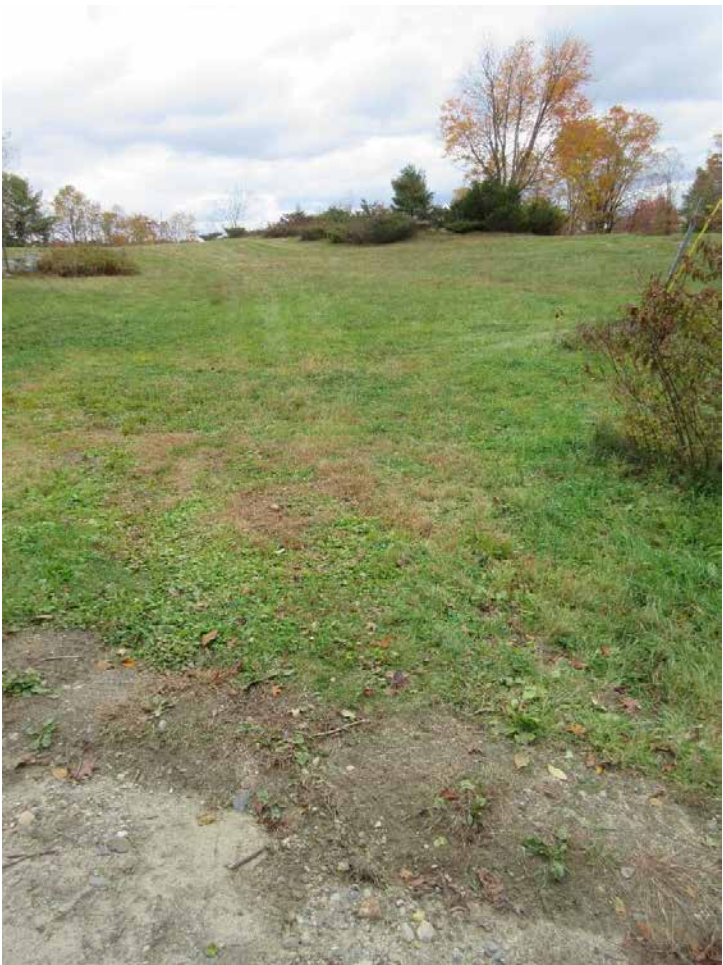
- Water runs off adjacent fields into the roadway, causing erosion.

Top: Fields above Gould Road that have lots of runoff into the road.

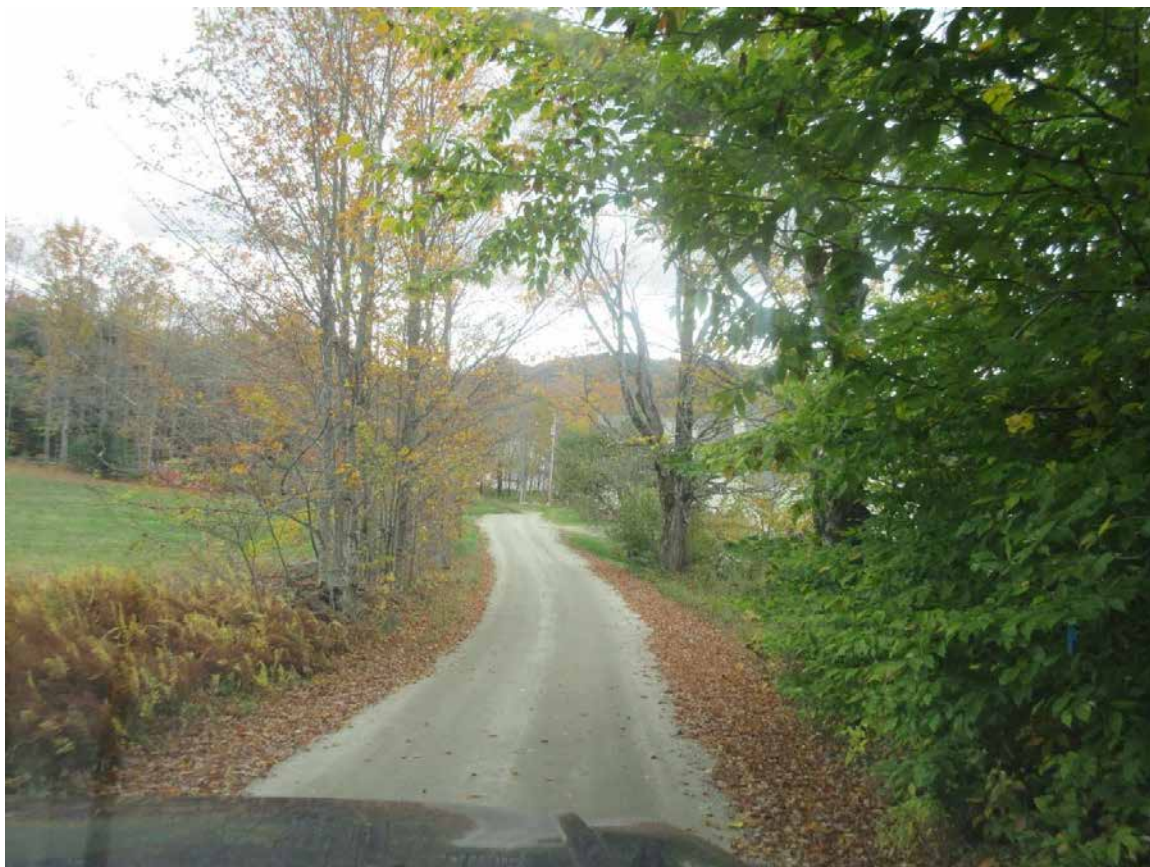
Bottom: Gould Road with fields on the left.

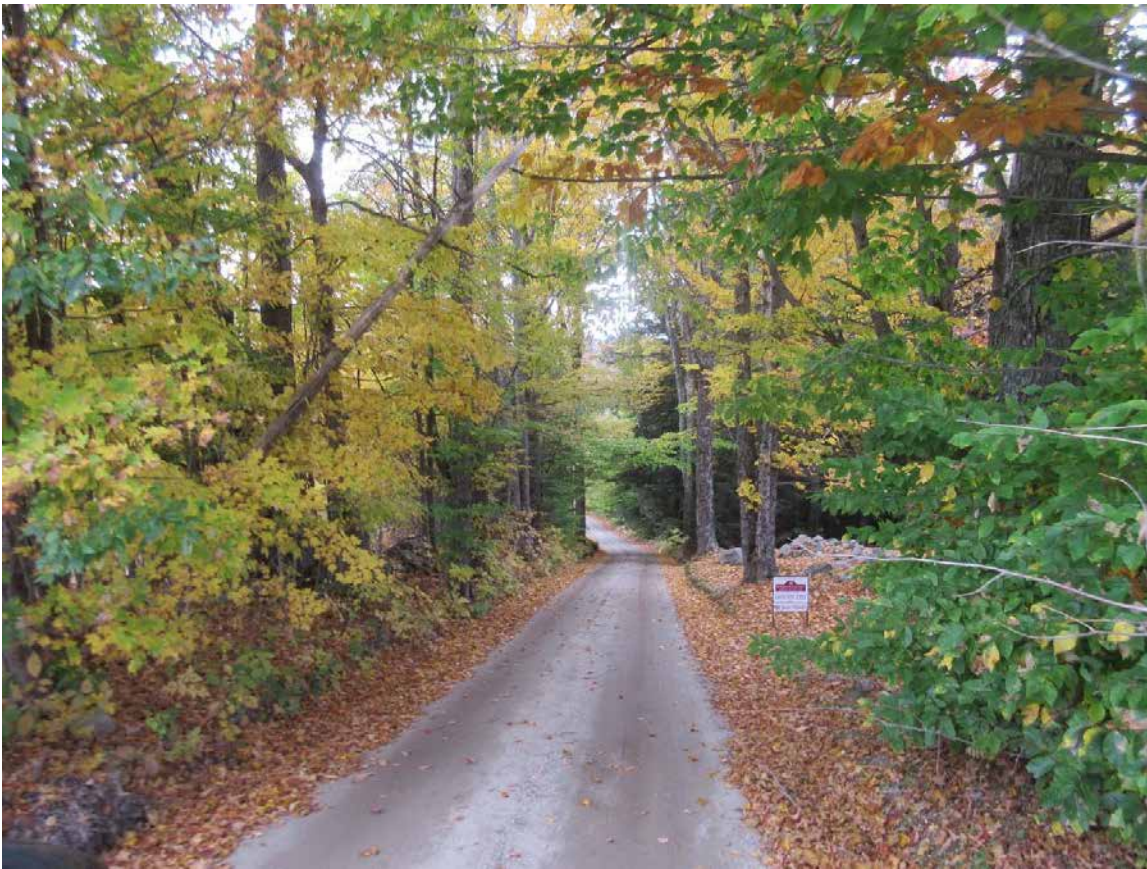
- Very steep road which is very narrow (trees and walls on either side) and has trouble with road erosion.

Top: Looking down Gould Road from near the top of the hill (and the townline with Baltimore). Trees close on both sides. Stone wall on right side.

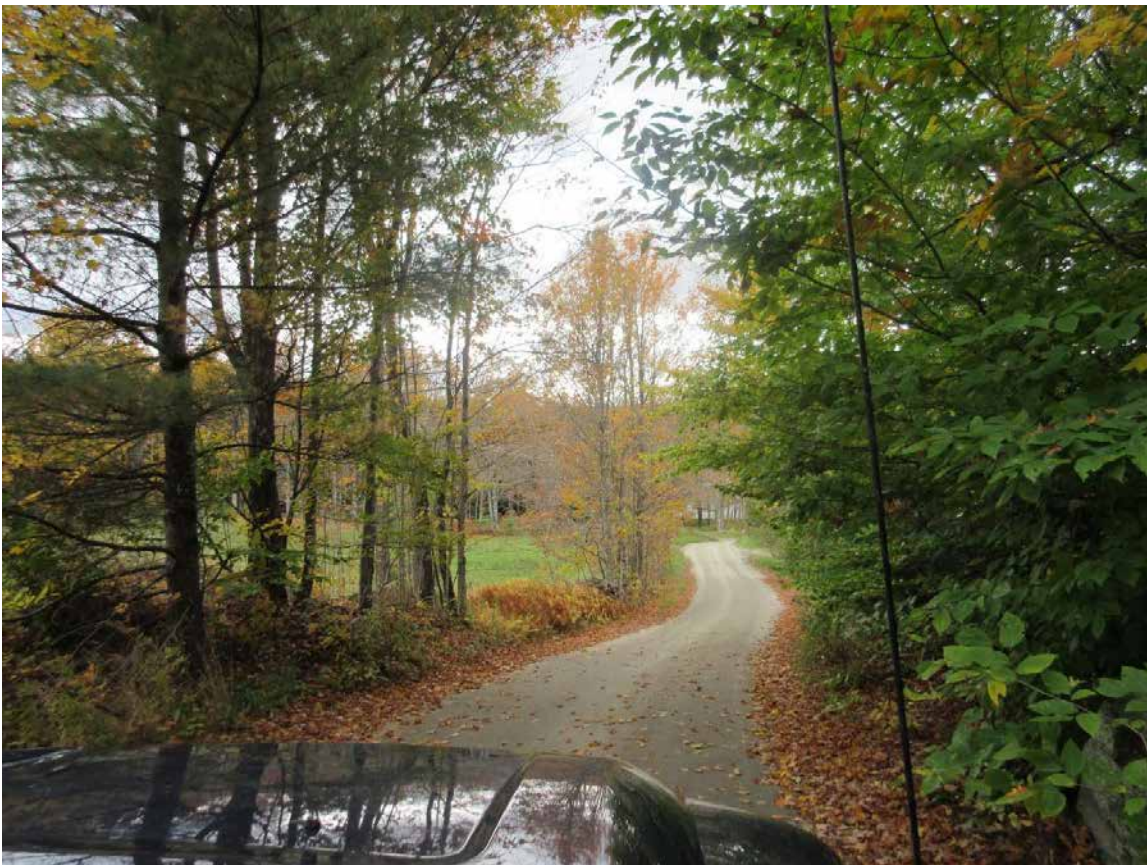
Bottom: Looking down Gould Road from near the top of the hill with drainage issues. Open area next to road in the background are the fields of Site K (Gould Fields).

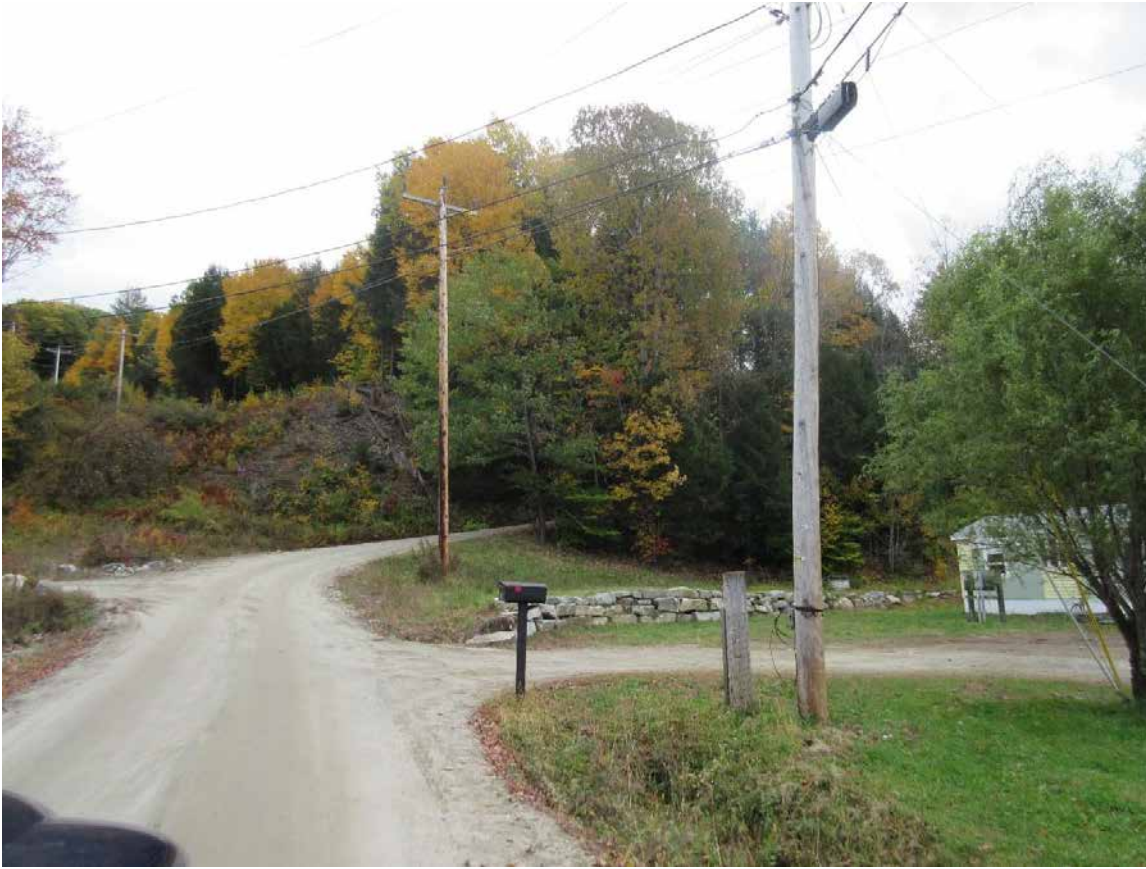
- Very steep road with drainage issues.
- Road is currently graded with a cross-slope so about 90% of stormwater goes into the ditch on the south side of the roadway.

Top: Bottom of big hill on Mineral Springs Road. Hill starts near the corner.

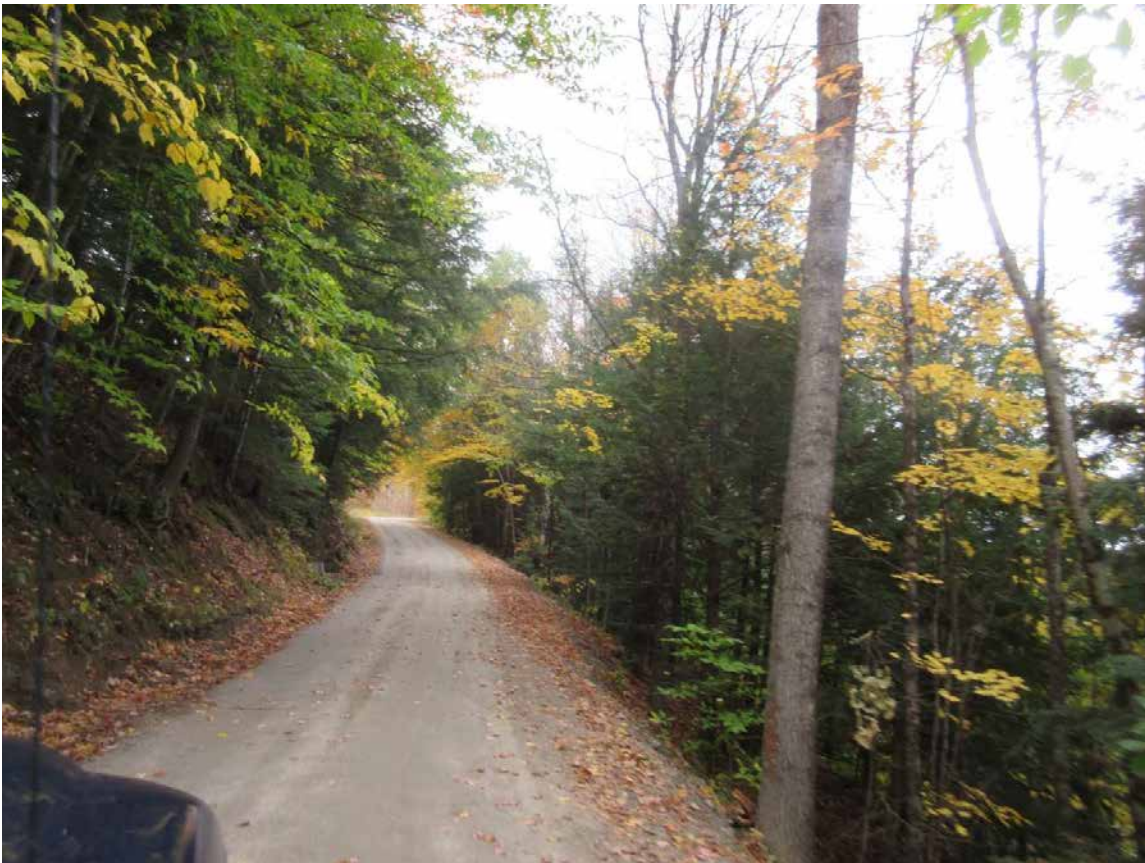
Bottom: Near bottom of big hill on Mineral Springs Road

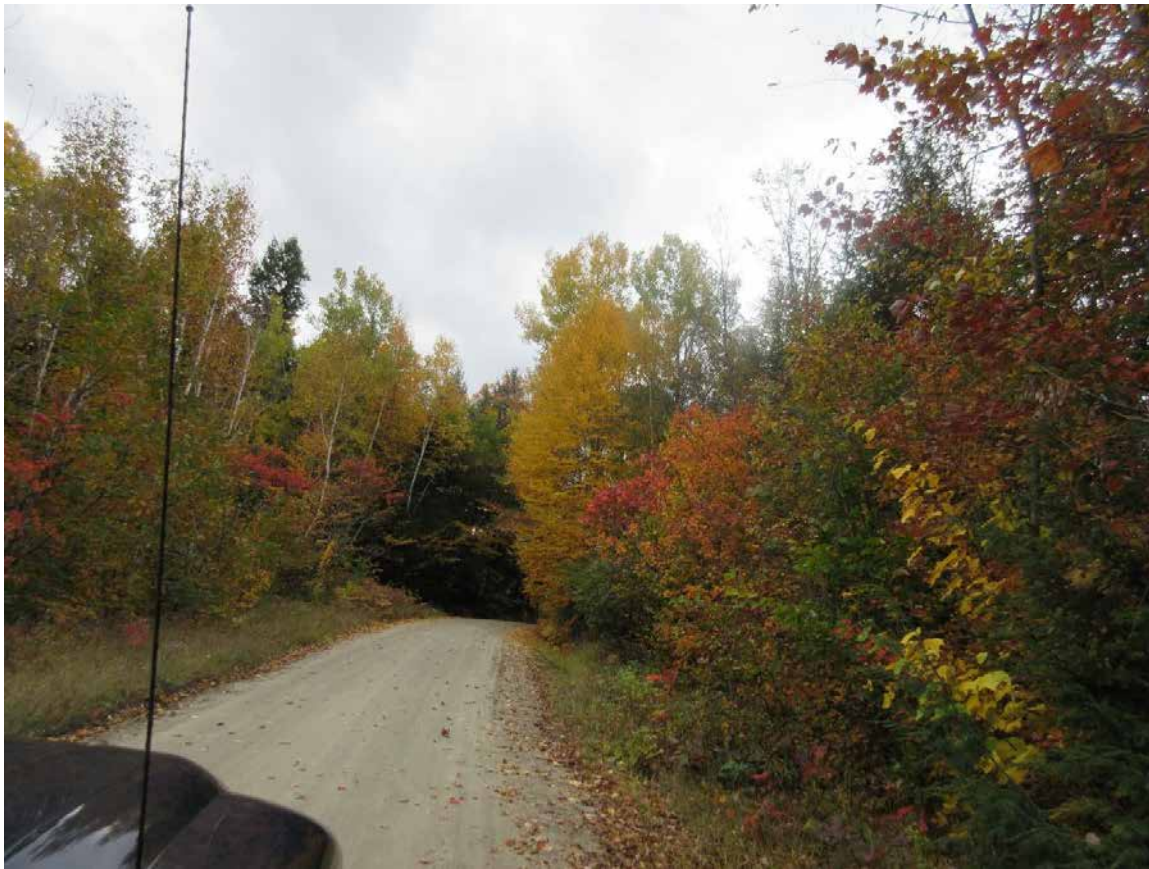
Top: Halfway up
Mineral Springs Road

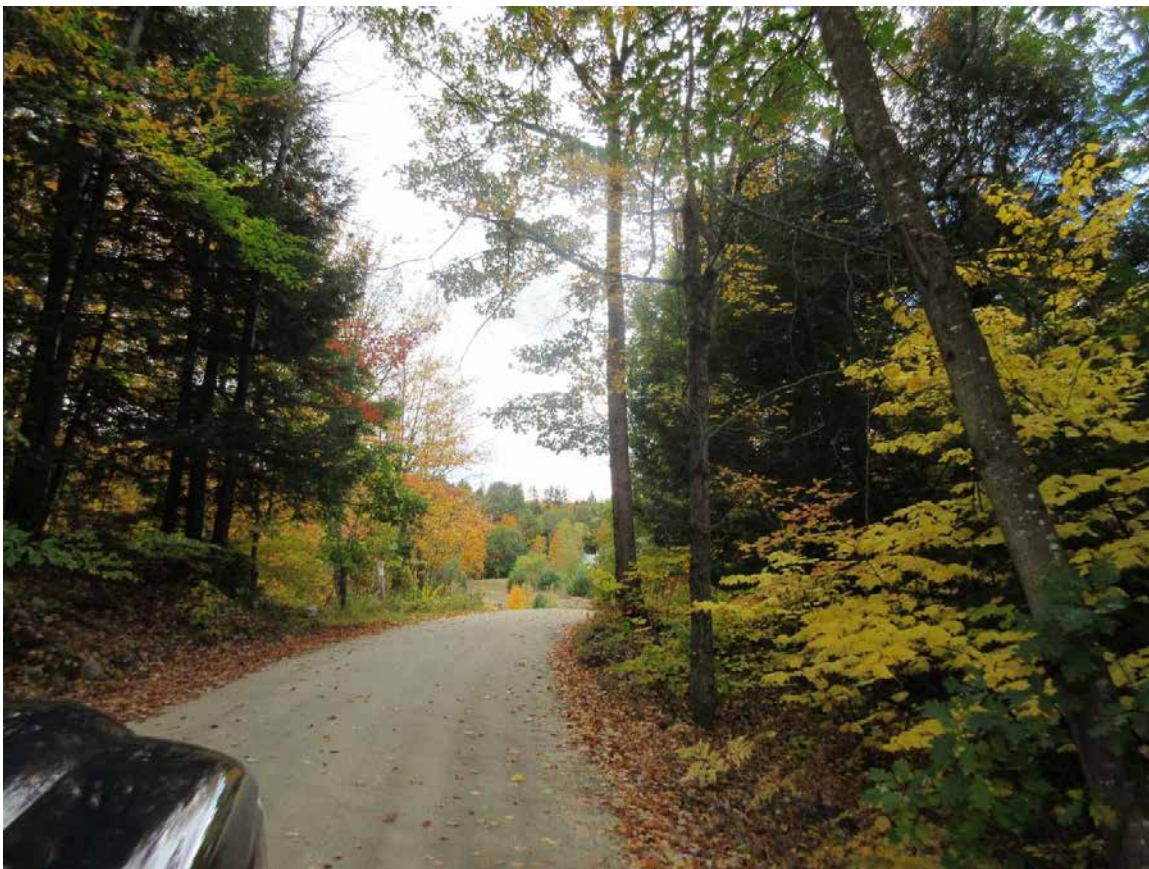
Bottom: Top of
Mineral Springs Road
