Town of Chester Road Erosion Inventory 2015

Completed by Southern Windsor County Regional Planning Commission and the Town of Chester

Fieldwork completed October 2015

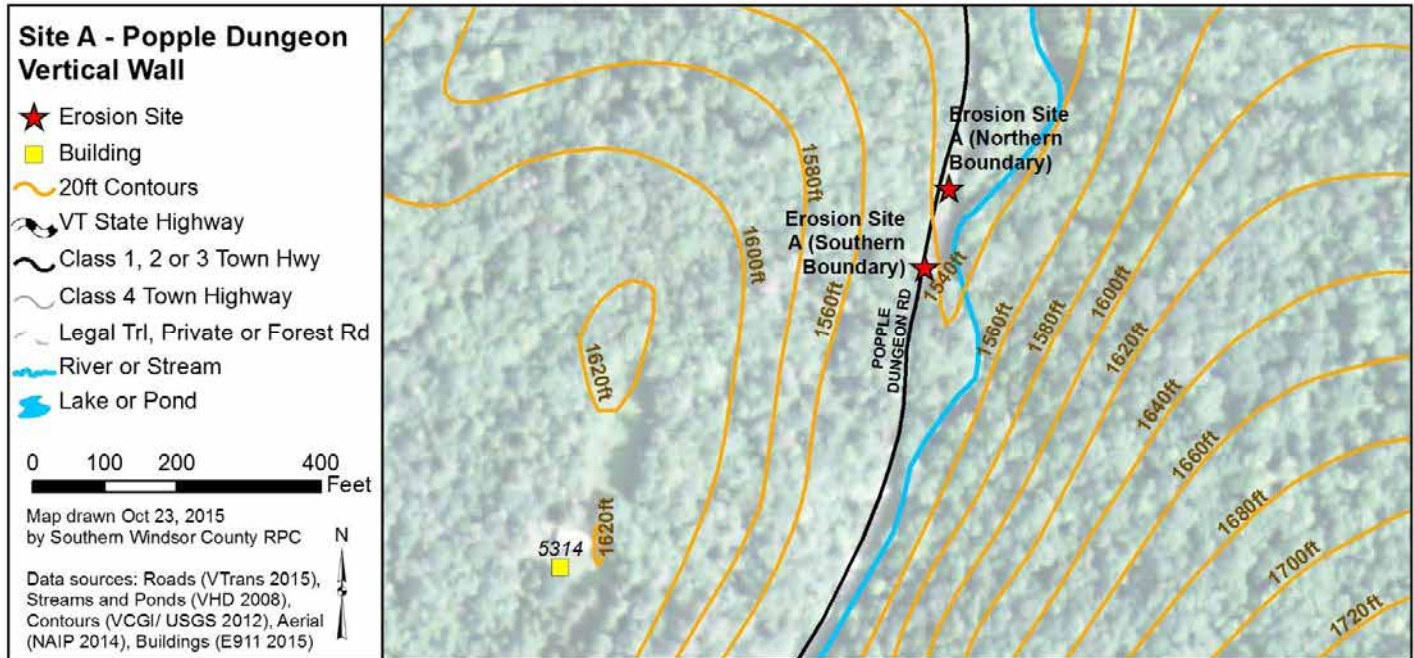
Site Map

- Stream right next to the road on a river bend.
- Road has issues with flash flooding (most recently 2011 and 2014) and beaver dams (every few years).
- Currently has 6ft concrete blocks to keep the bank vertical (160ft long, 14ft high), but that is not good hydrologically and not a permanent fix.
- Road washes out regularly and the existing concrete blocks will eventually fail.
- Site also needs guard rails, but there currently is not sufficient space.

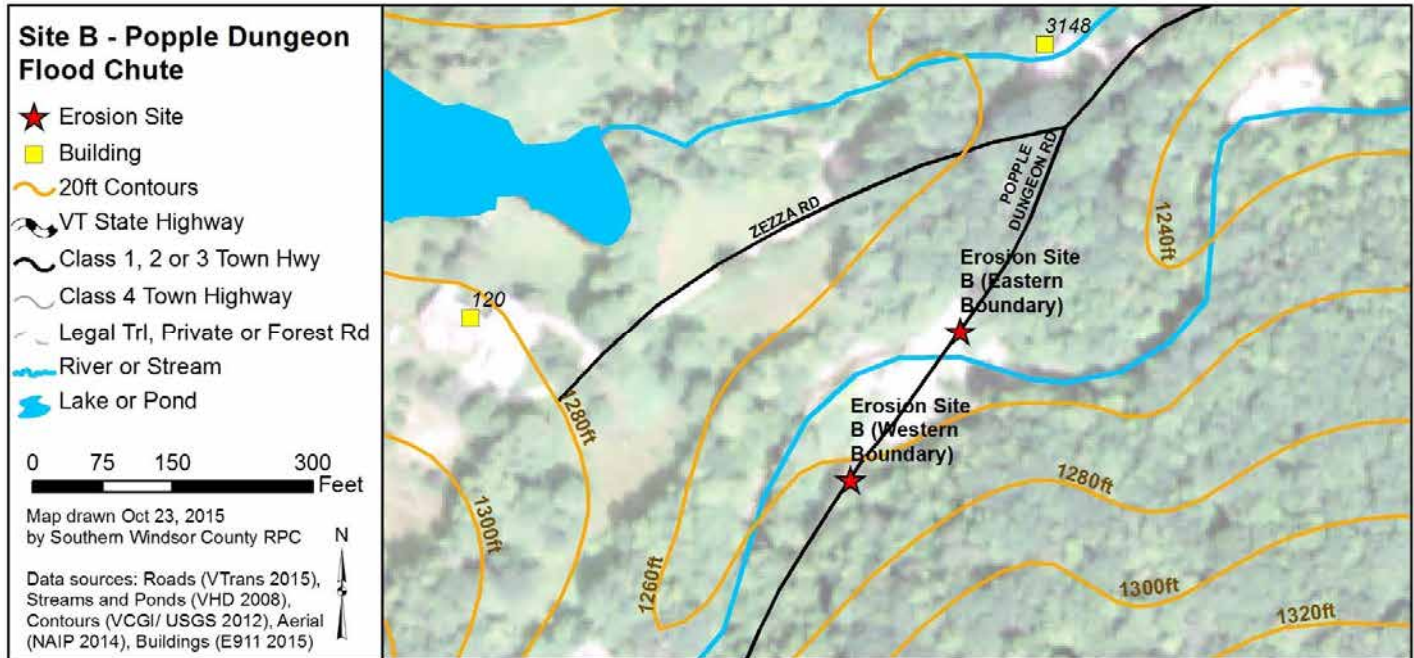
Site Map

- During major rain events and the resulting fluvial erosion, an approximately 100ft section of road repeatedly washes away as it becomes the flood chute (most recently in 1996, 2011 and 2014).
- The river approaches the current large elliptical multi-plated culvert at an angle.
- Each time the river creates the flood chute fill is needed for a section of roadway 120ft long, 20ft high and 60ft in width.
- It is currently a squashed 11ft corrugated culvert. It has a rusted out base, so water is now undermining underneath and to the sides of the culvert. It is also perched – which causes a barrier for aquatic organism passage.

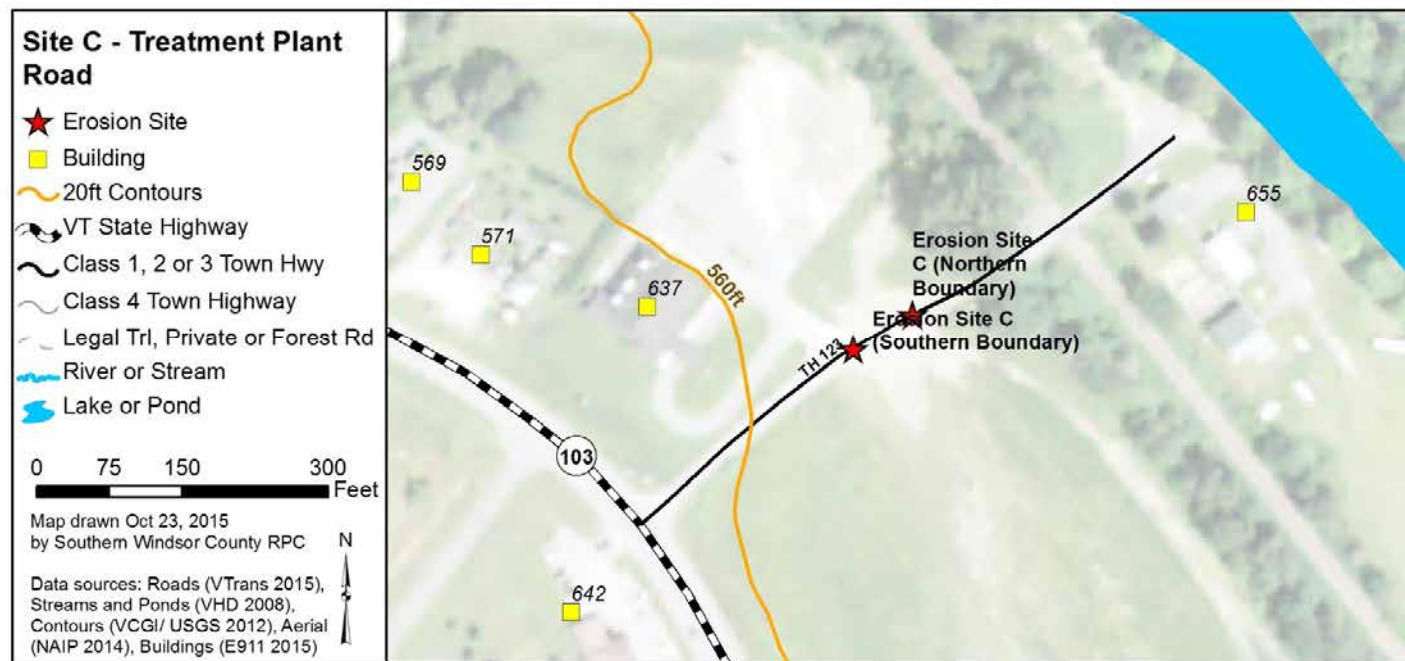
Site Map

- Williams River creates a flood chute in extreme rain events that cuts across the Ball Field and Sewer Plant Road. This happened in both 2011 and 2014.
- The river would overwhelm anything you put in – culverts, bridges, etc – so instead the highway department has used a temporary fix. The temporary fix is an unpaved section within the paved road, just filled with crushed gravel after each event to restore the roadway.
- This road is important as it serves the town sewer plant.

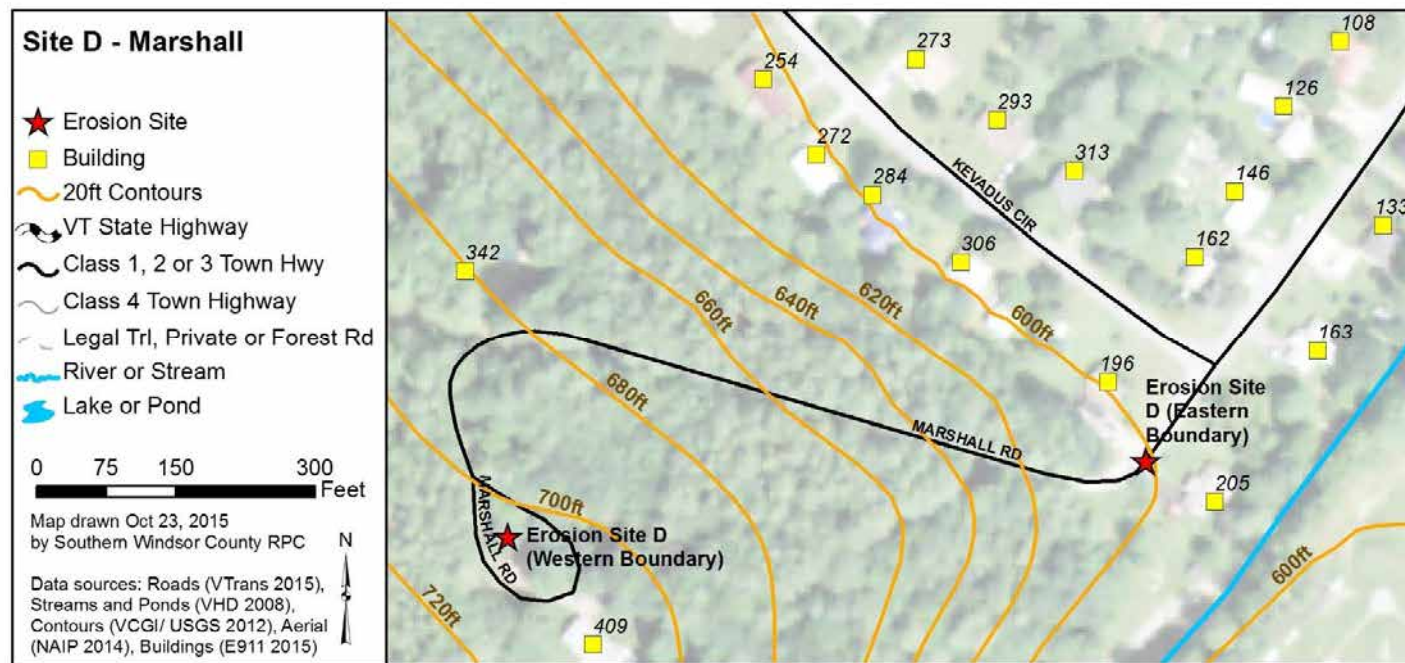
Site Map

- Water runs down a steep hill onto the residential development below (Marshall Road and Kevadus Circle).
- From about halfway down the hill the unpaved roadway has been graded with a cross-slope so that:
 - 90% of the water drains into the ditch on the south side which then runs into a chute which flows into a stream. This chute has a good amount of distance and grass between the roadway and the stream to prevent water quality issues.
 - 10% of the water drains into the ditch on the north side which then runs through a short amount of very steep woodland into the residential development below. This development does not have any storm water capacity and the water table is very close to the surface there.

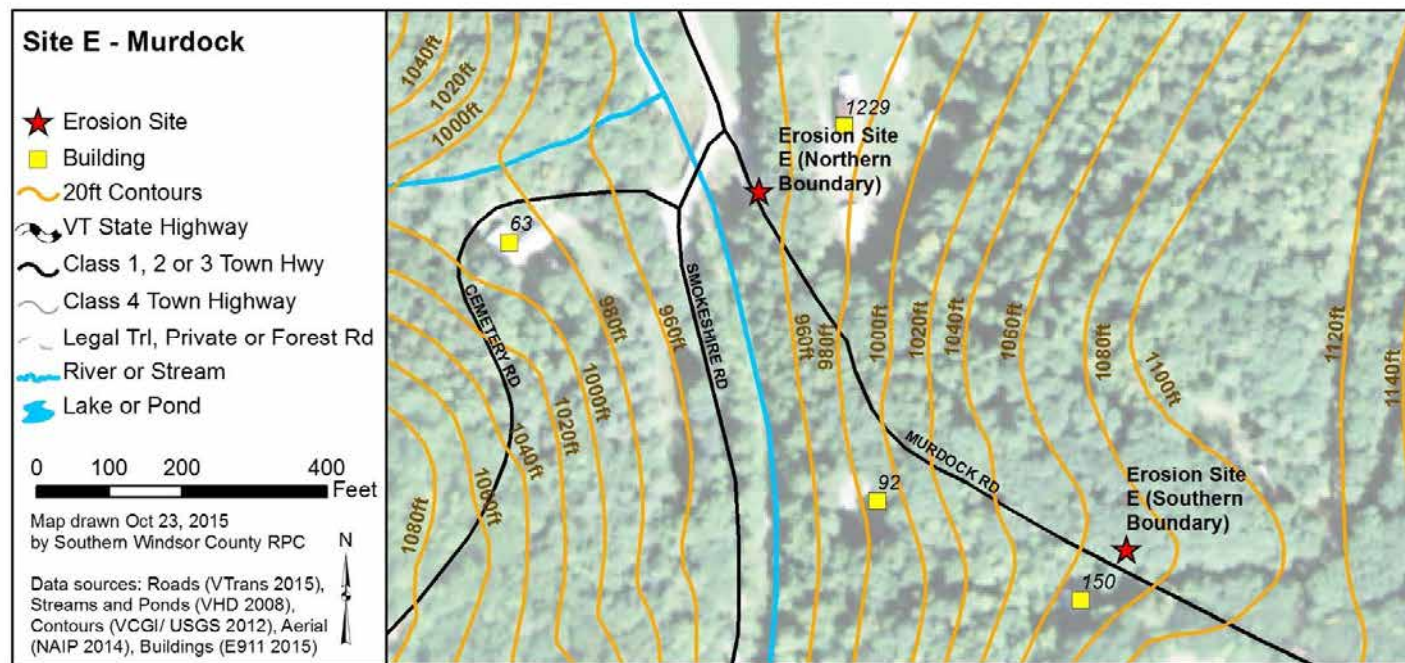
Site Map

- Very steep roadway where ditches are easily overwhelmed.
- Small berm (half a foot) on the downslope side keeps the road together, but cannot last forever.
- Sheets of water go over the road and the side of the road straight into the stream causing a water quality issue

Reinforce the downslope side of the road with riprap. Need to keep the trees in place, but the trees would cause issues for large rock.

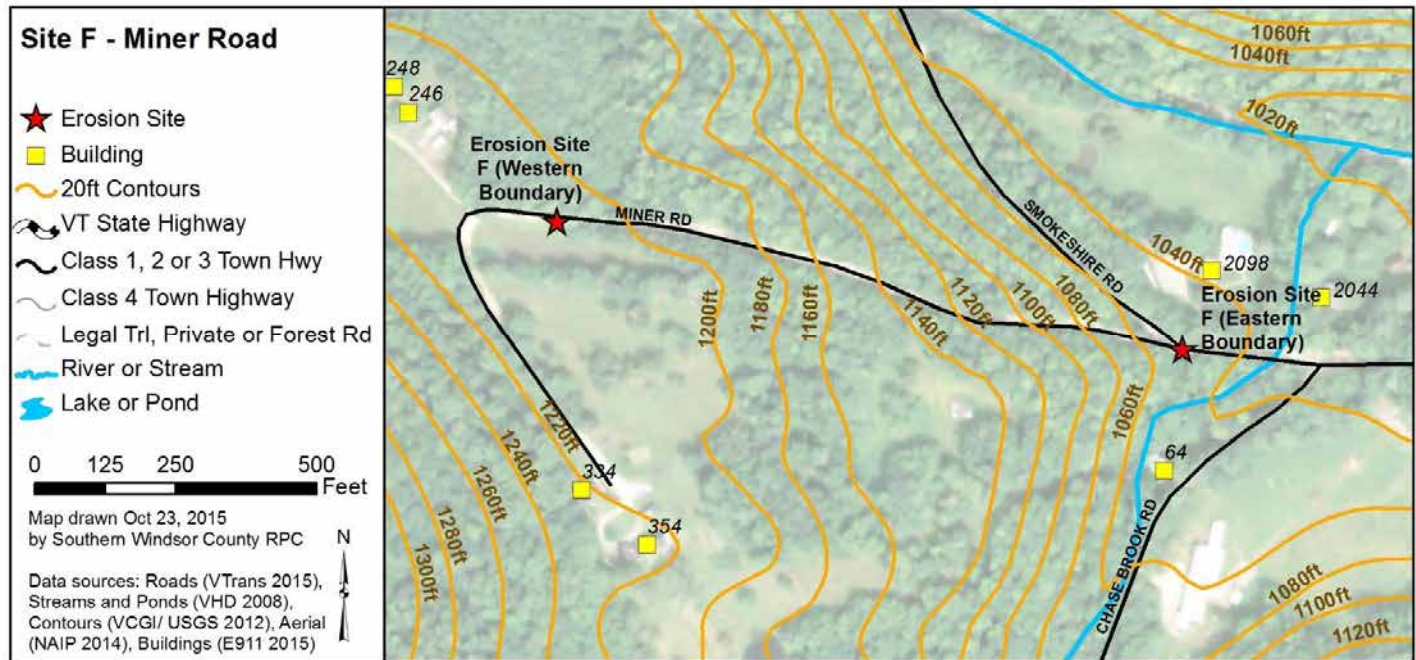
Site Map

- Very steep roadway.
- Ditches need improvement.
- Area does not have a water quality issue as the water leeches into the woods before it reaches the closest stream.

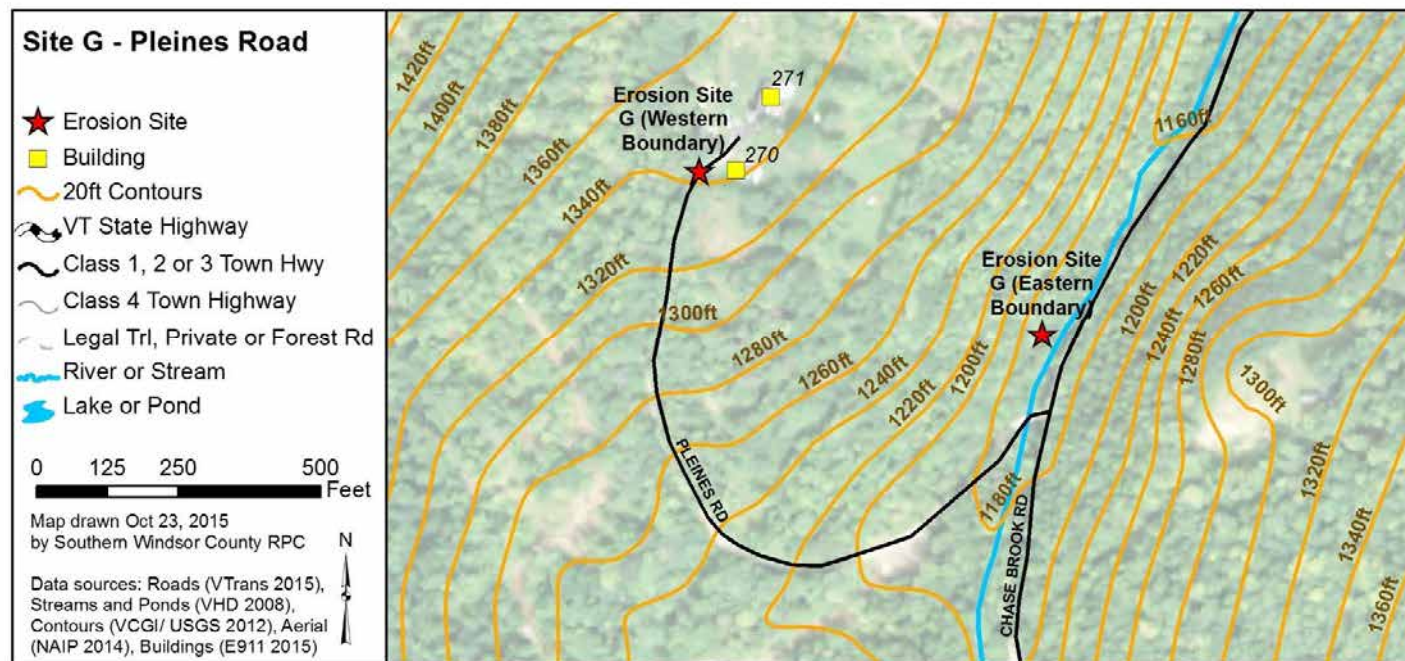
Site Map

- Very steep roadway.
- Ditches need improvement.
- Area has water quality issue because the water flows straight from the road into the adjacent stream.

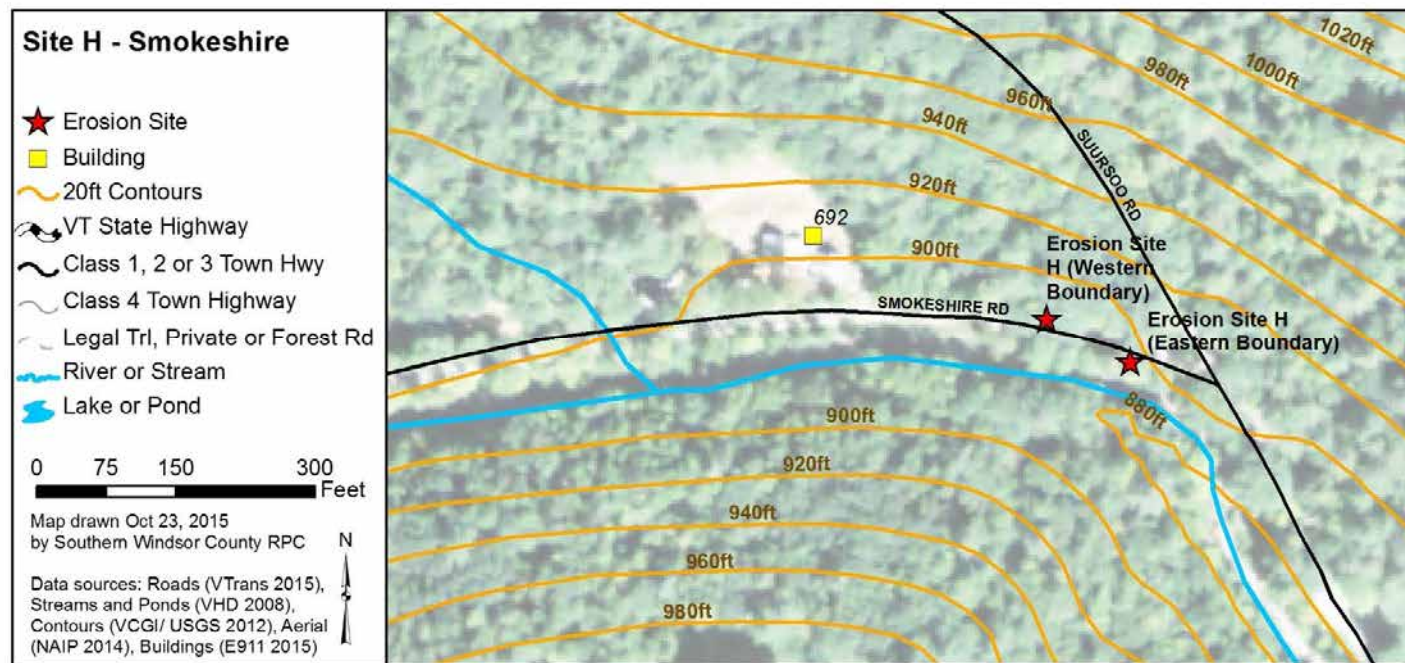
Site Map

- Road edge starting to collapse and undermine right next to the stream. One very small section currently has issues, but problem will occur along far longer section of roadway before too long – only a few trees left holding the bank together.
- Steep (vertical) slope of approximately 15-20ft between road and river.
- Road cannot move very far away from the river as ledge is very close to the road edge, and there is another steep road paralleling the road just above it (Suursoo Road) which would have to be relocated if Smokeshire Road was relocated.

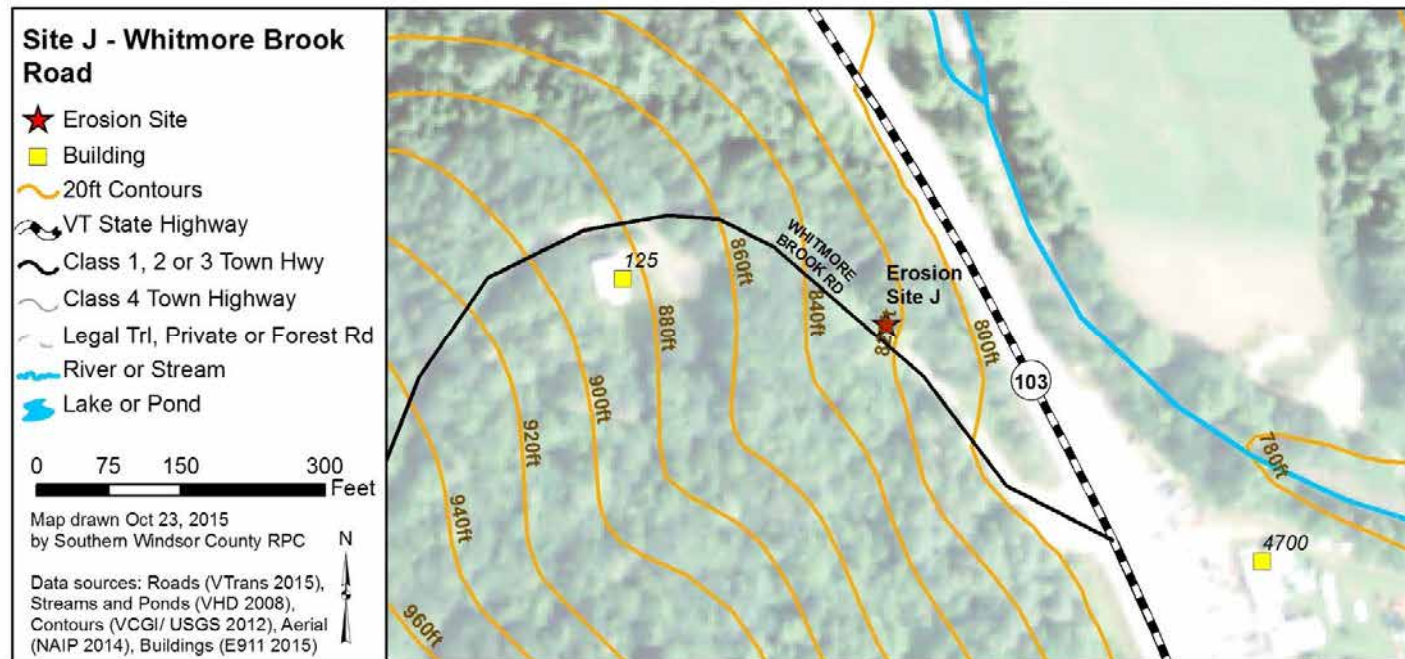
Site Map

- Double culverts (both 24 inch diameter) do not adequately handle water – particularly during icy conditions.
- Complex situation including a steep bank with waterfalls and pools below – which end right next to VT-103.
- Culverts have marble headers – which are not found anywhere else in town – except within VT-103 ROW. Unknown reason

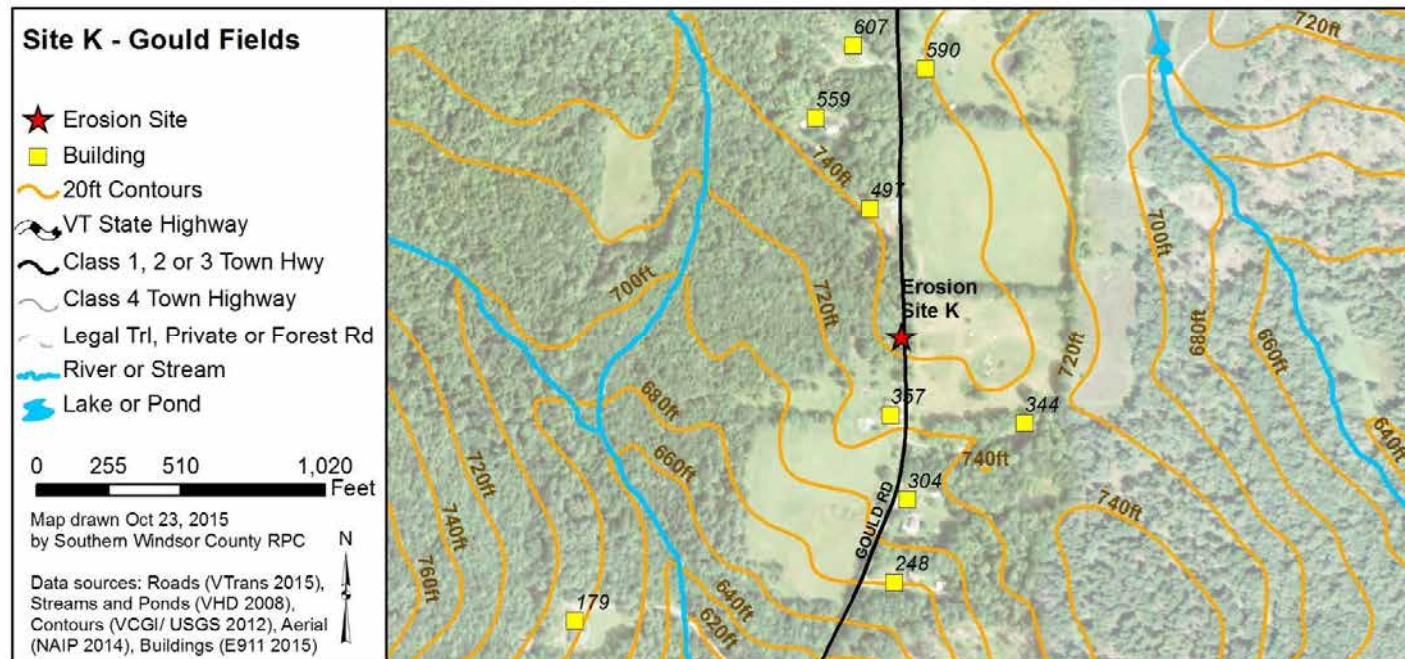
Site Map

- Water runs off adjacent fields into the roadway, causing erosion.

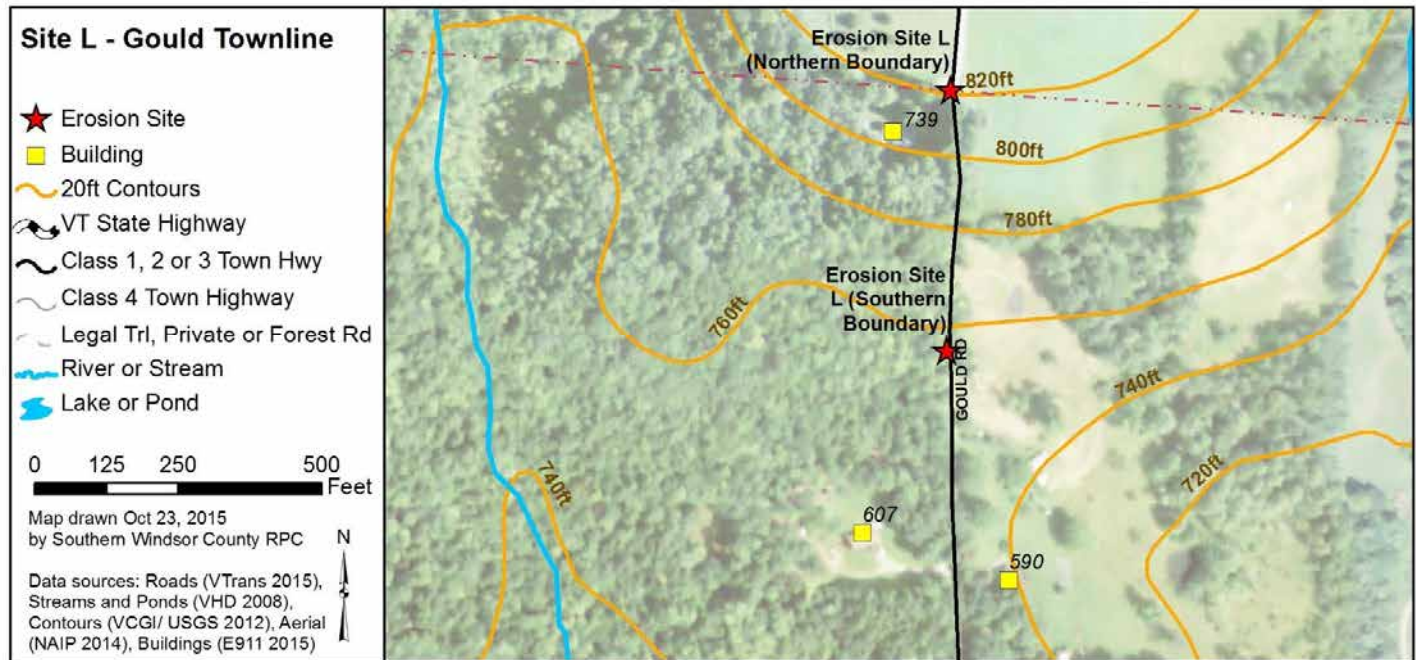
Site Map

- Very steep road which is very narrow (trees and walls on either side) and has trouble with road erosion.

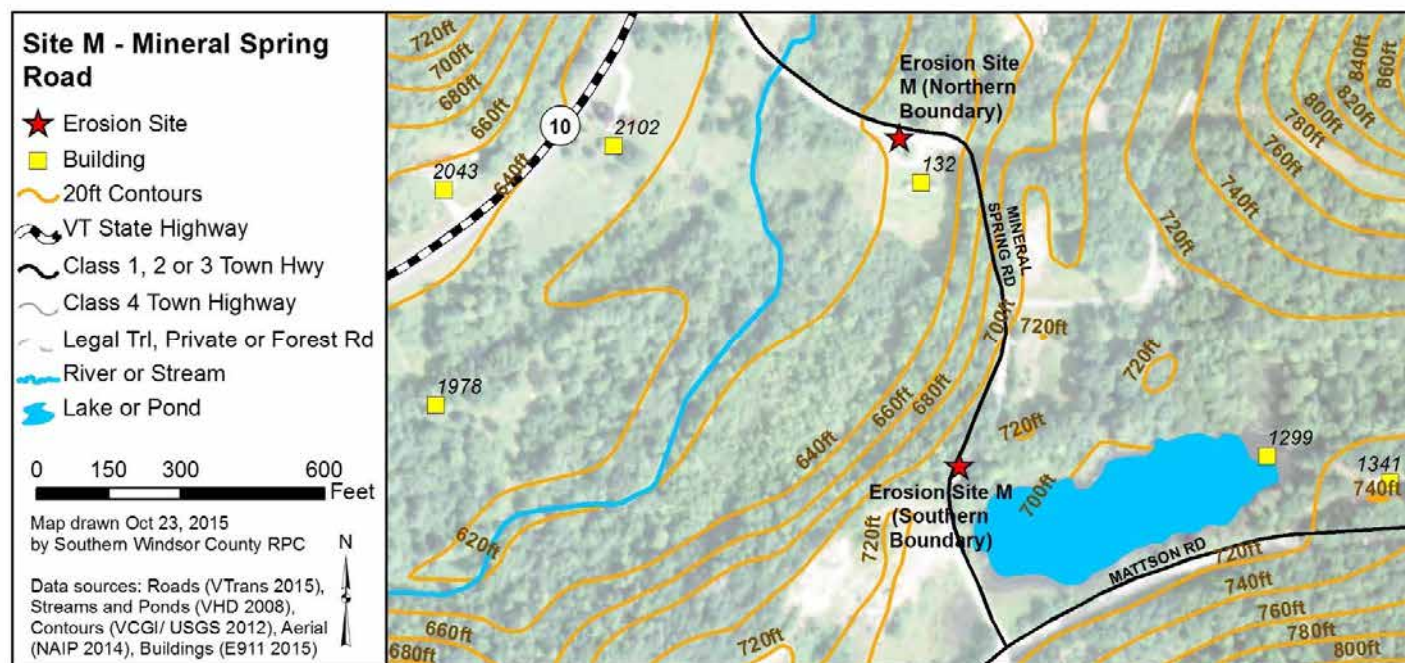
Site Map

- Very steep road with drainage issues.
- Road is currently graded with a cross-slope so about 90% of stormwater goes into the ditch on the south side of the roadway.
